## 4.2 Basin Summaries

## 5. DISCUSSION

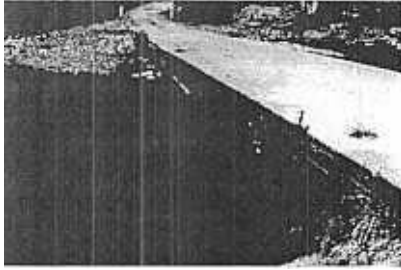
Figure 4.11: Culvert in the Shoalhaven River Basin (Sho 70).

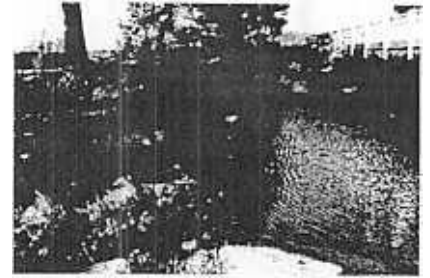
Figure 4.12: A causeway in the Wollongong Coast Basin (Min 17).

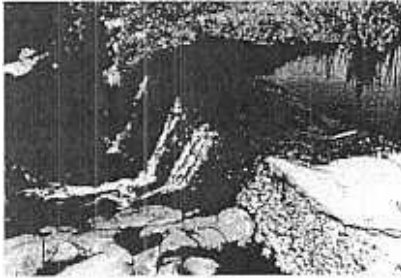
Figure 4.13: A fixed-crest weir in the Clyde River-Jervis Bay Basin (Cly 05).

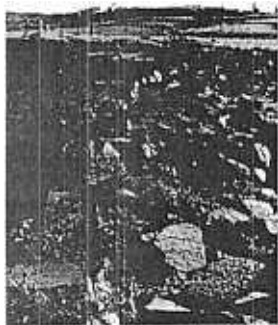
Fishways are fitted on two of the obstructions, MacDonaldis Weir (Mac 12) (site code) and Kurarroo Rock Weir (Min 13). Both of these are rock-ramp fishways (Thorncraft and Harris 1997; Berghuis *et al.* 1997; Harris *et al.* 1998). The maximum vertical height of an obstruction (14.8 m) was at Fountaindale Dam (Min 02), the minimum height (0.25 m) at Miala Crossing (Ill 02), and the average obstruction height was 2.48 m.

Figure 4.15a: View across a rock ramp fishway in the Wollongong Coast Basin (Mac 12).

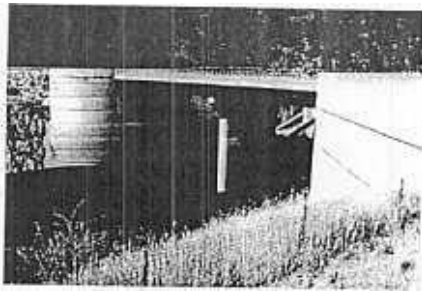
Figure 4.16a: Upstream view of high dam wall at Jindabyne on the Snowy River Basin (Sno 06).

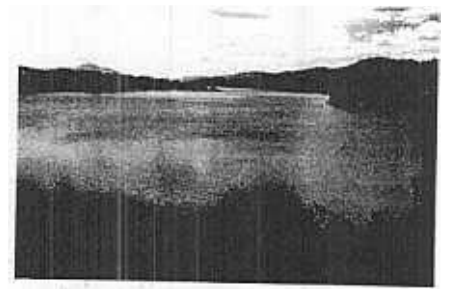
Figure 4.16b: View of the storage upstream of Sno06.

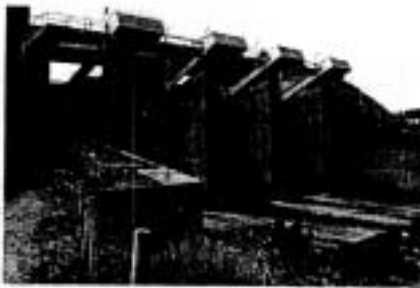
Figure 4.16c: Downstream view of the dam wall of Sno 06.

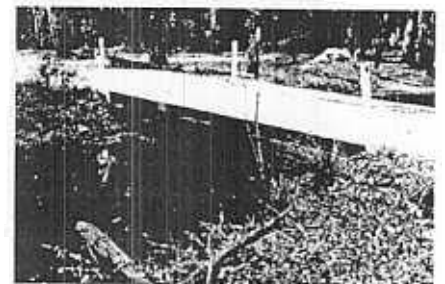
Figure 4.18: A low bridge in the Moruya River Basin (Mor 02).

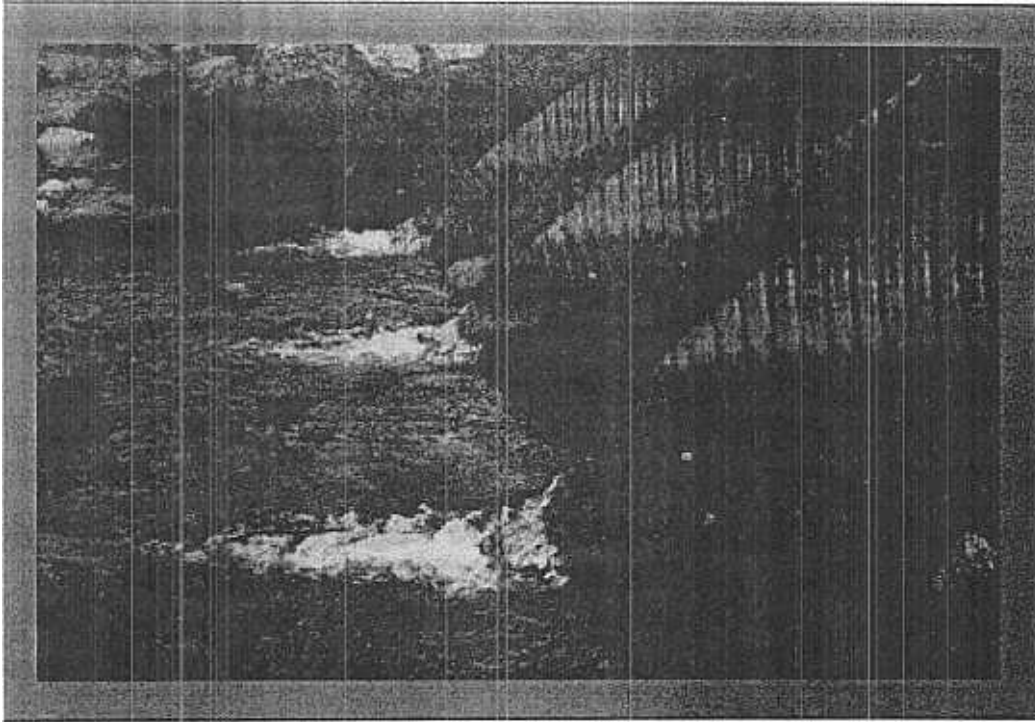
There are important differences in the relative effects of the different types of structures. In culverts, even though water may be flowing through the pipes, these are often too narrow, or too elevated above the surface of the water, so they would not allow fish passage upstream. An example of this type of culvert is the crossing near Thredbo (Sno 12) (see Figure 6.2).

Figure 6.2: A culvert in the Snowy River Basin (Sno 13)

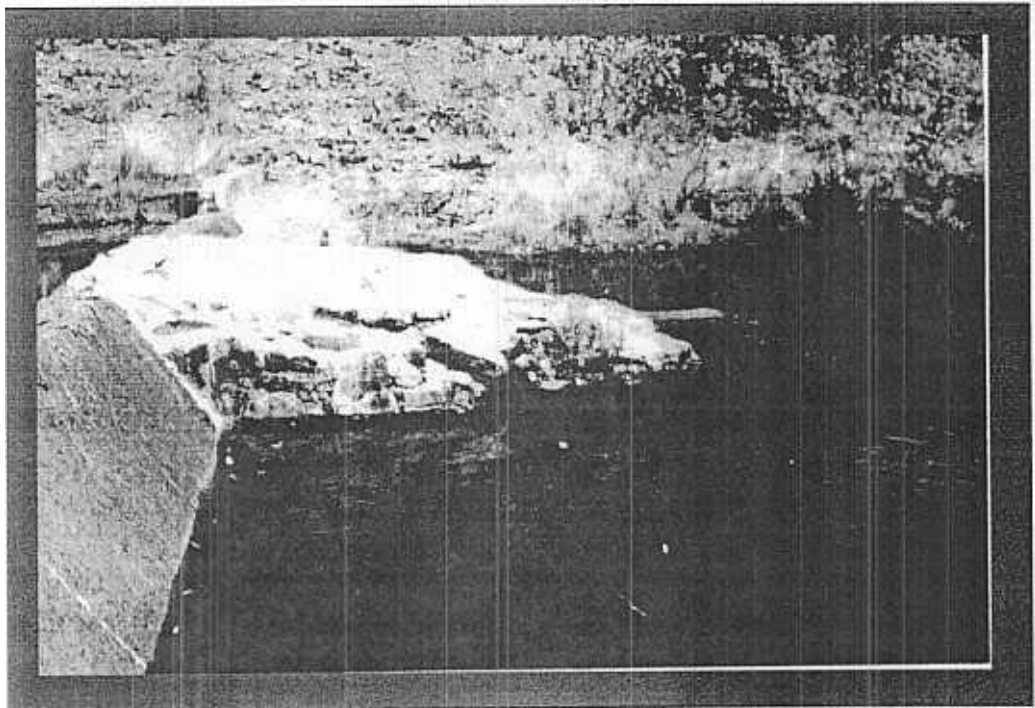
Although fishways have been constructed on seven of the south coast stream obstructions to allow for fish passage, some of them are ineffective. For example, the fishway observed on the McLaughlin River Weir (Sno 04) was a pool fishway, and completely ineffective at low flow because most of the pools are above the surface level of the water (see Figure 6.3). Fishways at Tapitallee Weir, Buckenbowra Weir and Anglers Reach were also recorded by Harris (1984b) as being non-functional.

Figure 6.3: An ineffective fishway in the Snowy River Basin (Sno 04)
