5. ASSESSING PRESENT CONDITION

5.1. Field observations

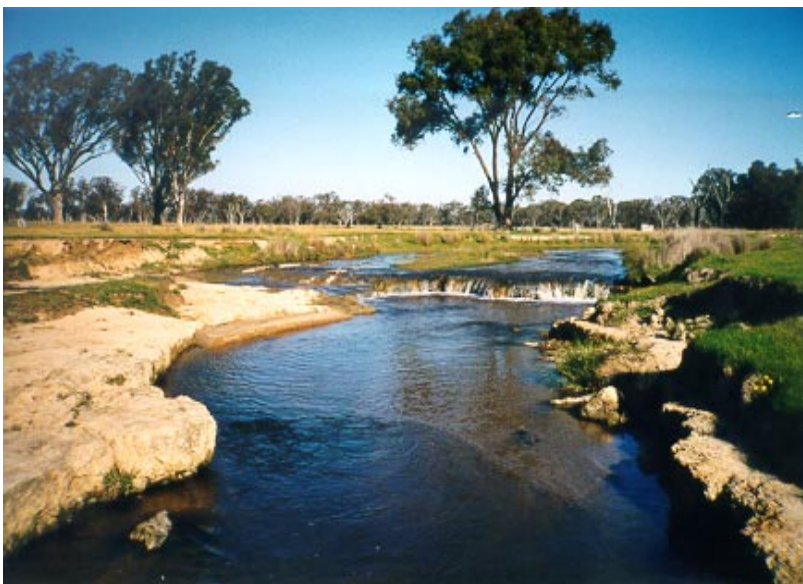
Fig. 5.1. An erosion head in Creightons Creek caught on resistant river rock

Bed erosion was evident in the main stem of Creightons Creek and several of the tributaries, in the form of erosion heads or knickpoints. These erosion heads were generally between 0.1 and 0.5 m high, though some were close to 1 m. Erosion heads were observed both above and below the Hume Freeway (i.e. in the hills and on the flats), with clusters evident at several locations, including on Branjee Creek, between Nelsons Rd and Drysdale Rd and on some of the headwater tributaries. Many of the erosion heads observed below the Hume Freeway were 'caught' on river rock (indurated river sediments) exposed in the bed of the creek (Fig. 5.1) and are consequently progressing very slowly upstream. The erosion heads observed above the Hume Freeway were in some instances caught on river rock, but were more commonly eroding through less resistant alluvial material (Fig. 5.2) and were, as a consequence, probably progressing upstream relatively quickly. Some work is currently being done by DNRE, the Goulburn-Broken Catchment Management Authority and a local land holder (Barrie Noye), which involves mapping erosion heads in the creek system to facilitate management.

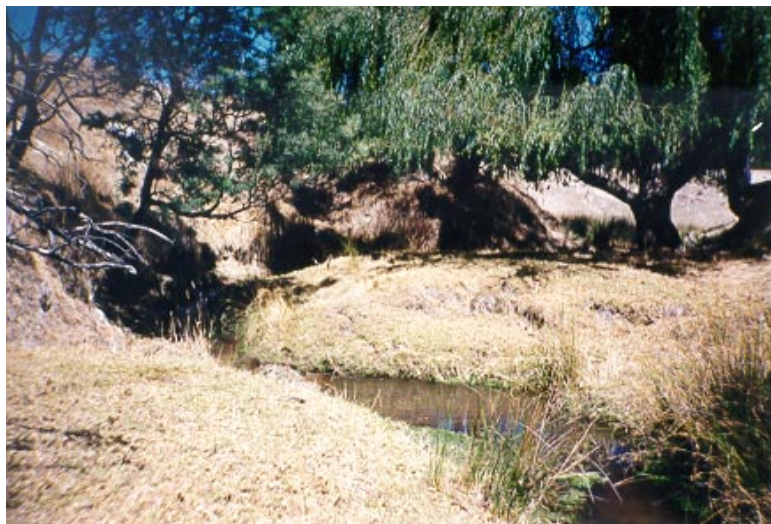
Fig. 5.2. An erosion head in Ramages Creek moving through alluvial material

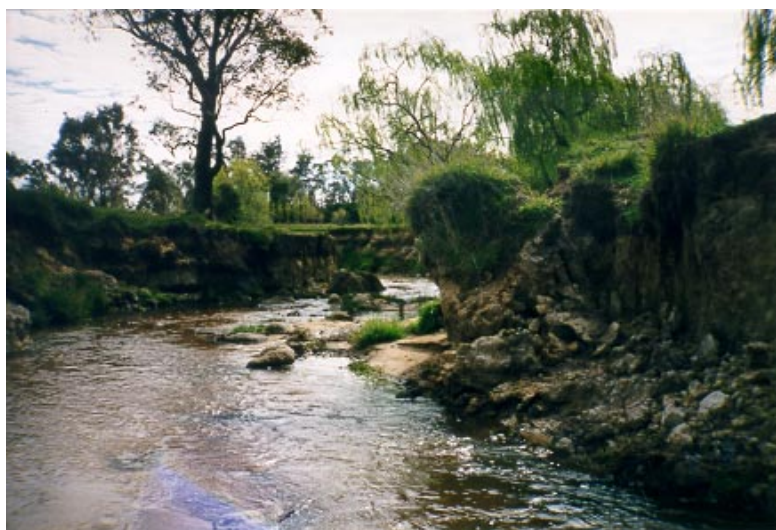
Fig. 5.3. Eroding stream-banks in the middle reaches of Creightons Creek

Bank erosion was also observed along the main stem of Creightons Creek, both upstream and downstream of the Hume Freeway. At a large number of sites, bank erosion (channel widening) has followed bed erosion (channel deepening). Channel widening following incision was evident above the Hume Freeway, both in the middle reaches (Fig. 5.3) and in the upper reaches of the creek (Fig. 5.4), as well as below the Hume Freeway (Fig. 5.5). While channel widening processes associated with incision would appear to be the main cause of bank erosion on Creightons Creek there are some sites where bank erosion has occurred for other reasons. There are, for example, several sites where bank

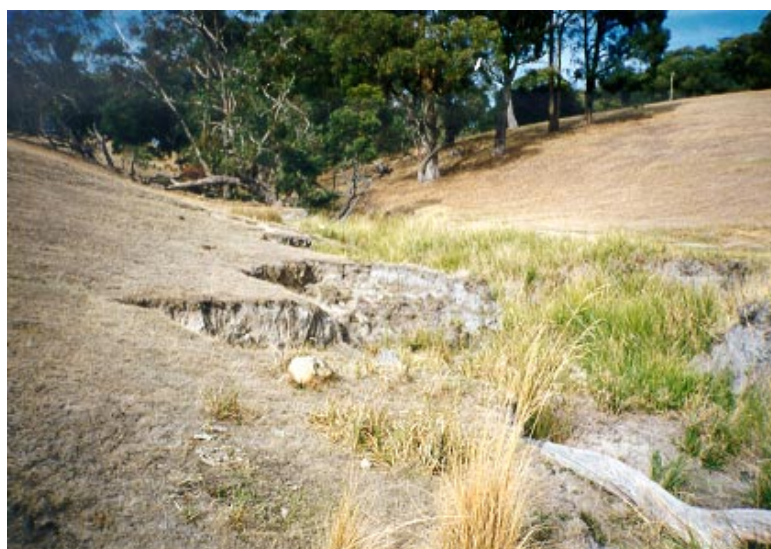
Fig. 5.4. Eroding stream-banks in the upper reaches of Creightons Creek

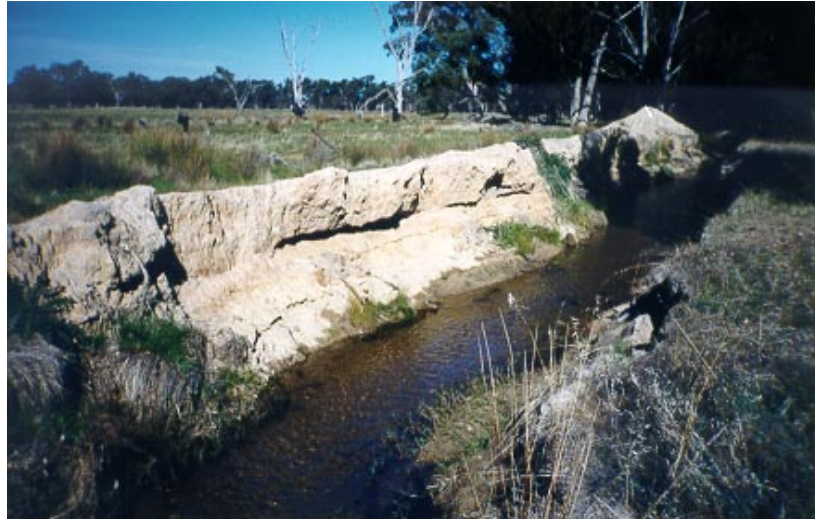
Fig. 5.6. Bank erosion on Creightons Creek due to undercutting

erosion is occurring as a result of stream migration, where the creek is undercutting the stream bank. Such instances are localised and in general are not a significant sediment source, but where these processes are active within a deeply incised reach of stream (such as on Stan Artridge's property (Fig. 5.6)) the potential sediment yield could be large. Bank erosion is also occurring at several sites along Creightons Creek and its tributaries as a result of stock trampling the banks (Fig. 5.7).

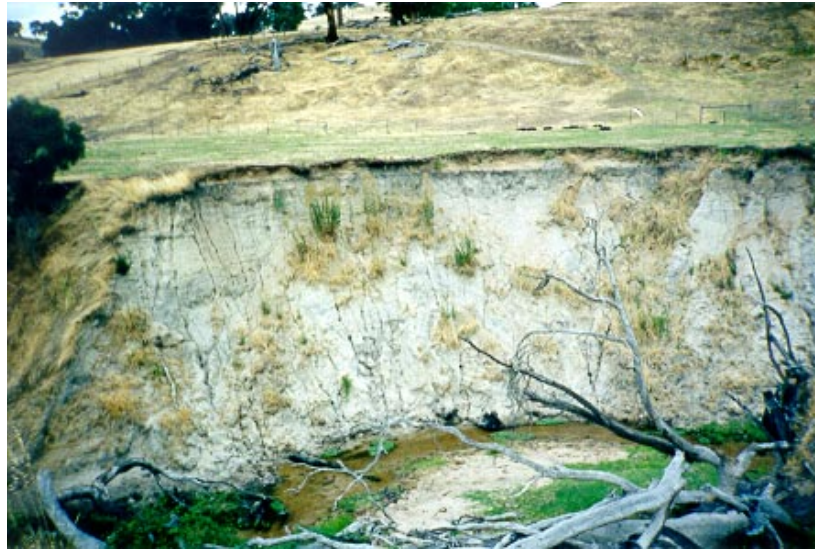
Fig. 5.7. Bank erosion on Creightons Creek due to stock trampling

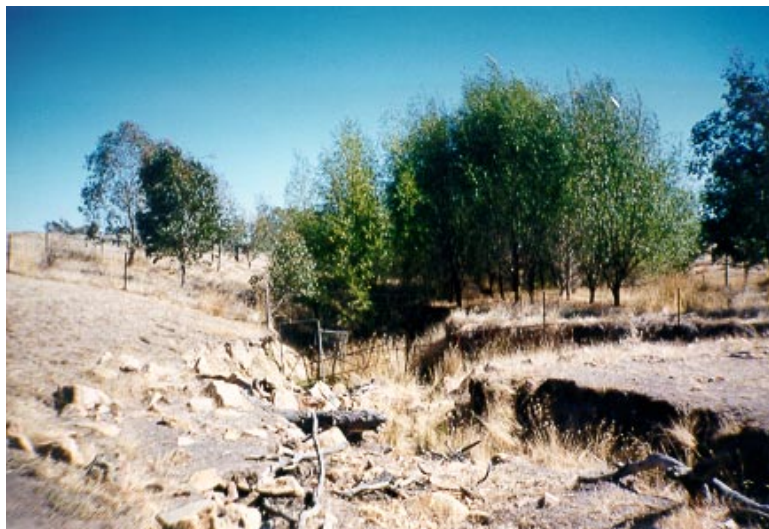
Fig. 5.8. A gully in the Creightons Creek catchment that has been fenced and planted with vegetation.

The third type of erosion observed in the Creightons Creek catchment is gullying. Active gullying has obviously been a problem in the past, with regard to the sediment released and farm management, but in most instances landholders have taken steps to address the problem, usually by fencing the drainage line out and planting vegetation (e.g. see Figs 5.8, 5.9). This is not to say gullying will not be a problem in the future, because anecdotal evidence suggests that where gullying has occurred in the past it has been in response to an activity (e.g. ploughing) or an event (e.g. storm, bushfire) which could also occur in the future. Gully erosion releases large quantities of sediment and this could also occur in the future, under the right conditions.

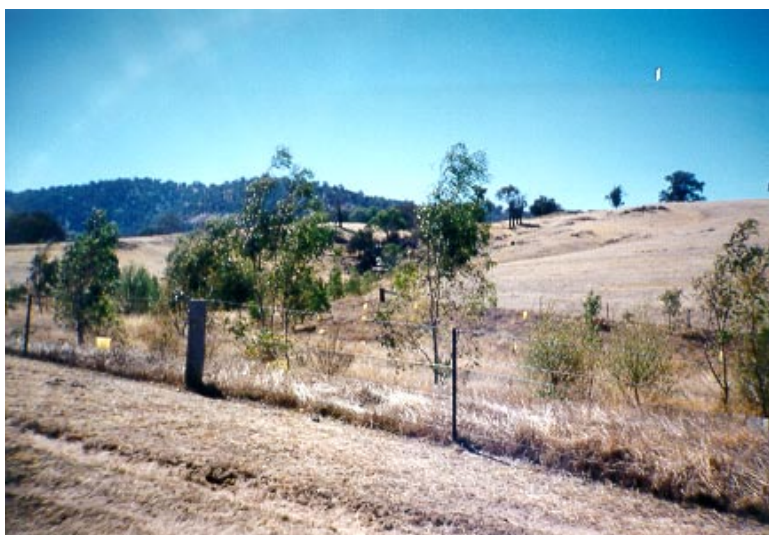
Fig. 5.9. A gully in the Creightons Creek catchment that has been fenced and planted with vegetation

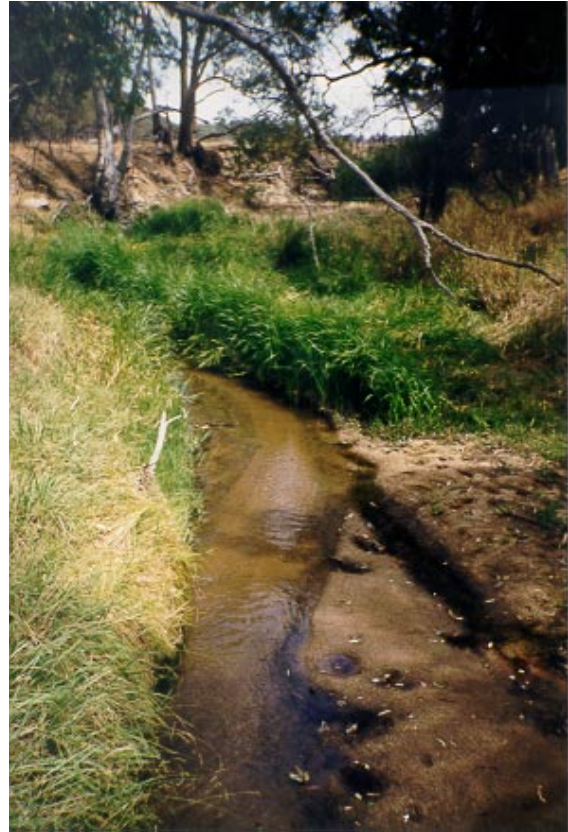
Fig. 5.10. A completely sanded reach of Creightons Creek

Downstream of the Hume Freeway the creek can be split into three segments. From the Hume Freeway down to the Longwood–Pranjip Rd (Branjee Creek) the creek is completely sanded, the channel is almost rectangular in cross-section and there is no variation in bed form (Fig. 5.10). The reach between the Longwood–Pranjip Rd and Pranjip Rd is a transition zone. In this reach sand is certainly evident but the volumes are not yet so large as to drown out the pool–run bed form (Fig. 5.11). Below Pranjip Rd some sand is evident in Branjee–Creightons Creek, deposited as sand drapes on the banks and point bars, but the total volume of sand deposited is minor as is its impact on the morphology of the creek (Fig. 5.12). While sand transport is clearly evident in the sanded segment, via dune movement (Fig. 5.13) and saltation of individual grains, the rate of movement of the snout of the sand slug is difficult to assess. The only piece of evidence available comes from

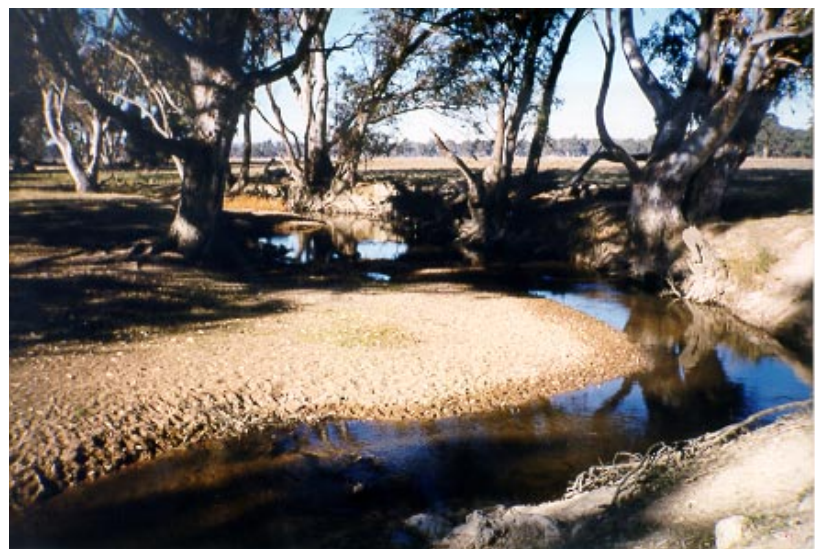
Fig. 5.11. A partially sanded reach of Creightons Creek

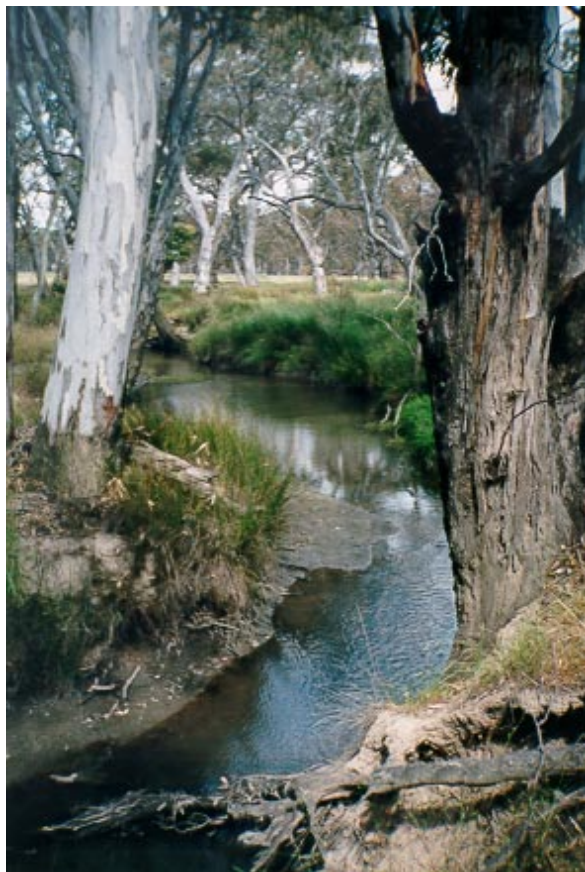
Fig. 5.12. Creightons Creek below the sand slug

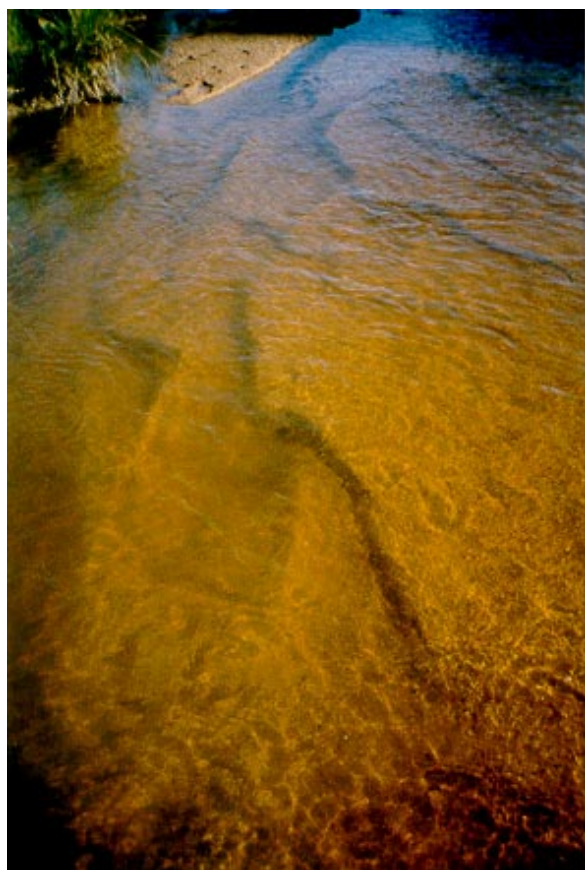
Fig. 5.13. Sand dunes migrating along Creightons Creek

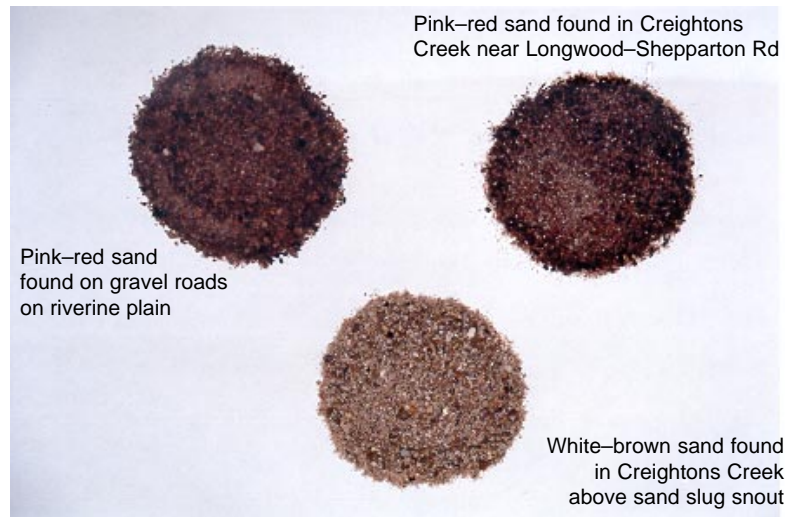
Fig. 5.14. 'Pink' and 'white' sand samples taken from Creightons Creek catchment

When viewed under a microscope the pink sand grains appeared to be clear quartz grains with a pink–red surface coating. This was confirmed when several grains were cracked open. While the pink–red surface coating was visible on some of the fracture surfaces it was not visible on others, suggesting that the surface and the more open fracture planes had been stained. The mineral composition of the sand is consistent with it having been derived from the granitic Strathbogie Ranges but it has subsequently been stained. The most obvious explanation for the staining is that the sand has been stored on the Riverine Plain for some time and during this period it has been subject to flooding and waterlogging — conditions in which iron can be mobilised (Bloomfield 1981). When the sediments were exposed to oxidation during periodic lowering of the water table, iron precipitated (Bloomfield 1981) staining the quartz grains a red–pink colour. If this explanation is correct then the pink sand can be considered, in the management time scale, to be the material into which the channels on the Riverine Plain have been cut and is the material which, though originally derived from weathering and erosion of Strathbogie granites, has been in storage on the plain for a significant time span. One would also expect to find pink sand in other reaches of Creightons Creek on the Riverine Plain, but most reaches upstream of Pranjip Rd have been inundated with ‘white’ sand which would have substantially diluted the pink colouring and buried the underlying material.

The main implication of the above explanation for the existence of the pink sand is that the sand found in Creightons Creek at the Longwood–Shepparton Rd and in Muddy-Waterhole Creek at Kirwans Bridge Rd is derived locally. Since the pink sand found in these locations has not been diluted by ‘white sand’ released recently from the upper catchment, it can be assumed that the lower reaches of Creightons Creek and Muddy-Waterhole Creek have not yet been affected by the sand slug moving down the system.

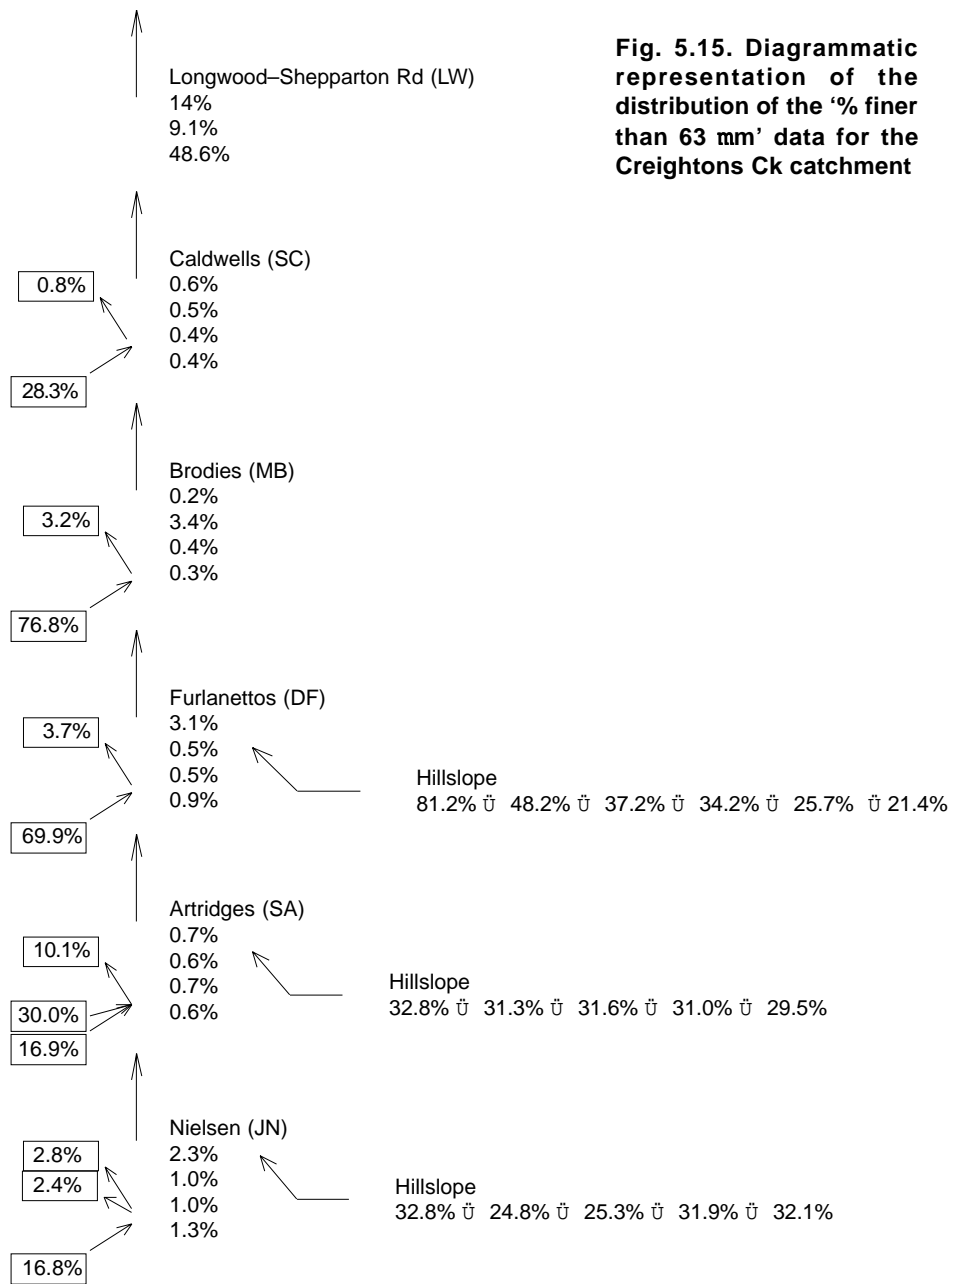
Several general patterns are visible in Fig. 5.15 (also see Fig. 3.1 for site locations) that are consistent with the expected movement of sediment that is less than 63 mm in size in a stream network. The percentage of fines is high on hillslopes and in the creek bed below the sand slug, low in creek beds and on adjacent banks (i.e. sand drapes deposited under moderate to high flow conditions) along the sand slug, and moderate or high in areas where deposition has occurred under low flow conditions (i.e. floodplain deposits that are now stream banks).

- ↑ Smiths (WS)
a%
b%
c%
d%
represents samples taken in Creightons Creek on the Smith's property (location WS), where the samples have a%–d% of their total mass finer than 63 mm
- ↙ Hillslope
e% ÷ f% ÷ g% ÷ h% ÷ i%
represents samples taken along a hillslope, where the uppermost sample has i% finer than 63 mm and the lowest sample has e% finer than 63 mm
- ↳ k%
represents a sample of material deposited adjacent to the channel, which is k% finer than 63 mm
- ↳ j%
represents a sample of potential source sediment from the channel walls, which is j% finer than 63 mm

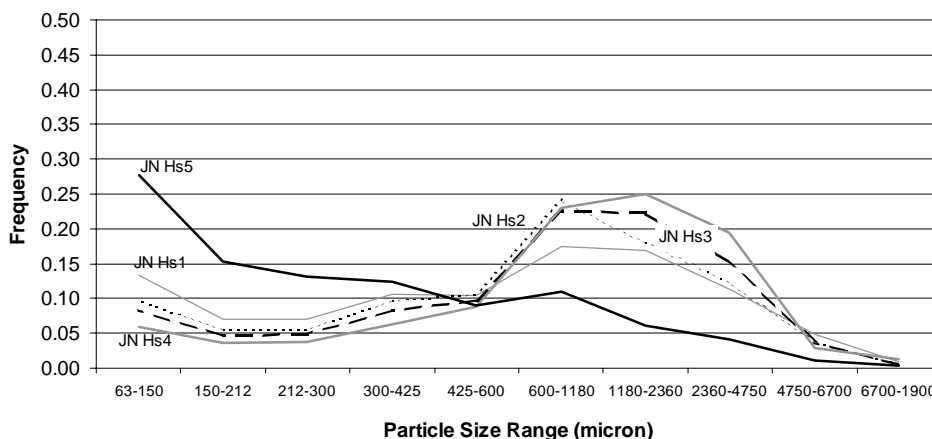
Fig. 5.16. Summary of hillslope particle size (mm) histograms for Site JN. Location '1' represents the top of the slope and location '5' is in the footslope.

A comparison of the particle size frequency histograms for hillslope samples taken at site JN is presented in Fig. 5.16. Inspection of Fig. 5.16 indicates that, with the exception of the lowest sample site, as one moves downslope the PSDs become coarser and better sorted. The lowest hillslope sample (JNHs 5) is, on the other hand, finer and more poorly sorted. This is consistent with material in the range 425 mm to 4.75 mm (medium–coarse sand) being eroded and redeposited downslope, while 63–425 mm (fine sand) material leaves the slope to be deposited in the footslope (JNHs 5) or transported into the stream network. The comparatively poor sorting found in the footslope might be explained by the fact that transport conditions at the footslope are completely different to the upslope sites, i.e. this area may store all the material derived from upslope, and possibly some material derived from upstream.

which is consistent with fines being eroded from higher up the slope and being redistributed down the slope, with the greatest amount of deposition occurring at the toe of the slope.

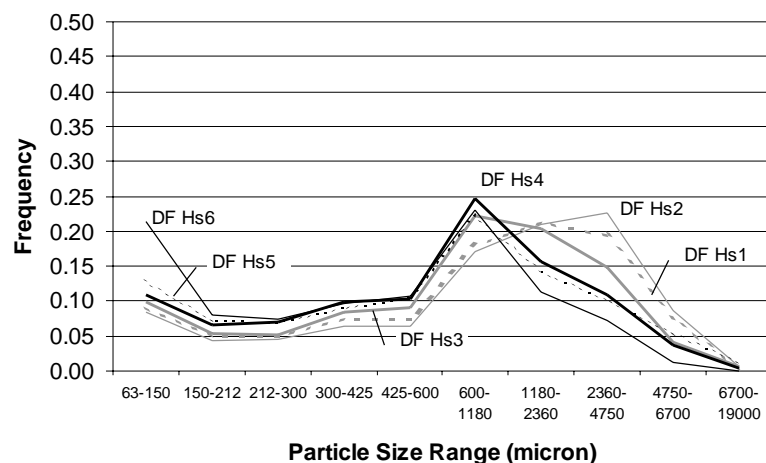
A comparison of PSD histograms for the hillslope at site DF (see Fig. 5.18) indicates a steady decline in the relative proportion of coarse material (1.18–19 mm) and steady increase in finer material (63 mm – 1.18 mm). Only at the base of the slope (DFHs 6) is there a substantial increase in the relative proportion of some size fractions (i.e. 63–150mm, i.e. fine sand). These observations are consistent with fine–coarse sand being mobilised on the slope, medium–coarse sand being redeposited on the slope and fine sand being deposited in the footslope area.

Fig. 5.18. Summary of hillslope particle size histograms — Site DF. Location '1' represents the top of the slope and location '6' is in the footslope.

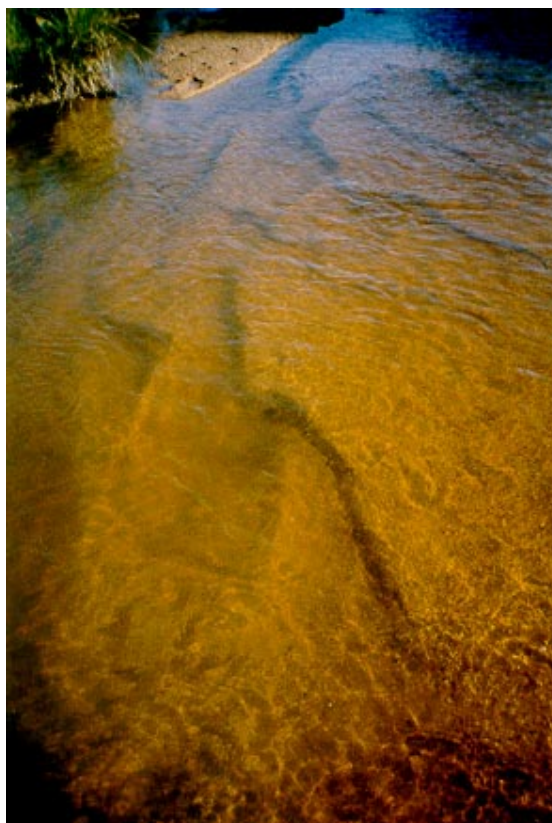
Fig. 5.26. An example of dune formation observed on Castle, Creightons and Pranjip–Nine Mile Creeks at various times

Dune formation was observed on many occasions in the sanded sections of Castle, Creightons and Pranjip–Nine Mile Creek, in both high and baseflow conditions (e.g. Fig. 5.26). Dune movement was monitored on one occasion at site MB following a bedload sampling run. The dunes observed on this occasion had an amplitude of 10 cm, a wavelength of 140 cm and a period of 5 minutes. The dune sequence was also observed to cover approximately one quarter of the channel width. The implications of these observations are that during spring baseflow up to 25% of the bed scours to a depth of 10 cm and refills every 5–6 hours.

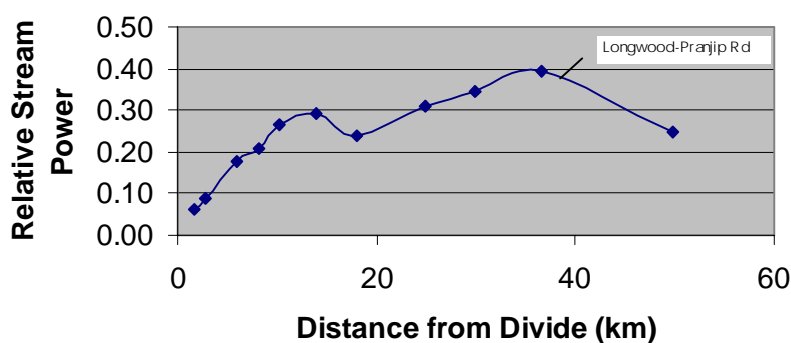
Fig. 6.1. Relative stream power vs stream length

A relative value of stream power was calculated for 11 points along Creightons Creek, starting in the headwaters, by multiplying catchment area by stream-bed slope (both catchment area and stream-bed slope were obtained from 1:25 000 topographic maps). The relative stream power against stream length is plotted in Fig. 6.1.

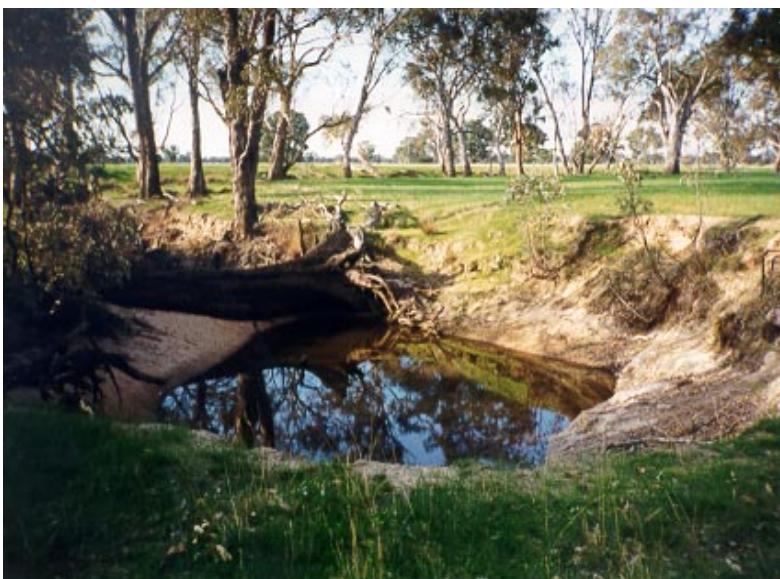
Fig. 6.2. Pranjip–Nine Mile Creek on the ‘flats’. The trunk of a large tree lying across the creek has created a large scour pool.

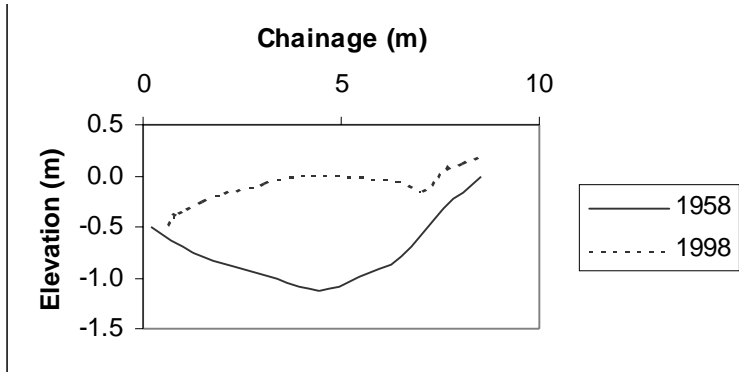
Fig. B1. Bed elevations for Pranjip Creek at the Hume Freeway for 1958 and 1998
