# **Sand Slugs and Stream Degradation: The Case of the Granite Creeks, North-east Victoria**

Cooperative Research Centre for Freshwater Ecology  
Technical Report 7/2000  
December 2000

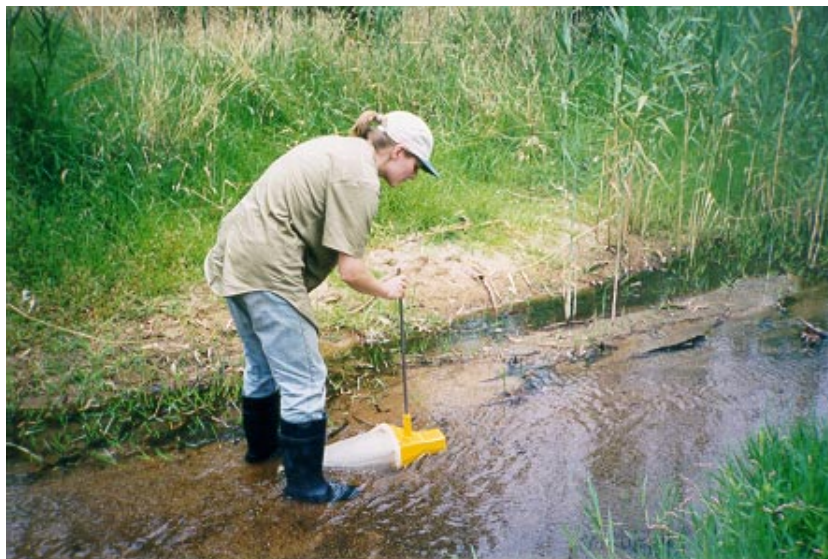
**Fig. 3.7. A small Helley-Smith Bedload Sampler being used to sample bed load in Creightons Creek**
