4. ANALYSIS OF HISTORICAL EVIDENCE: ESTABLISHING BASELINE CONDITIONS AND POTENTIAL EROSION TRIGGERS

4.1. Introduction

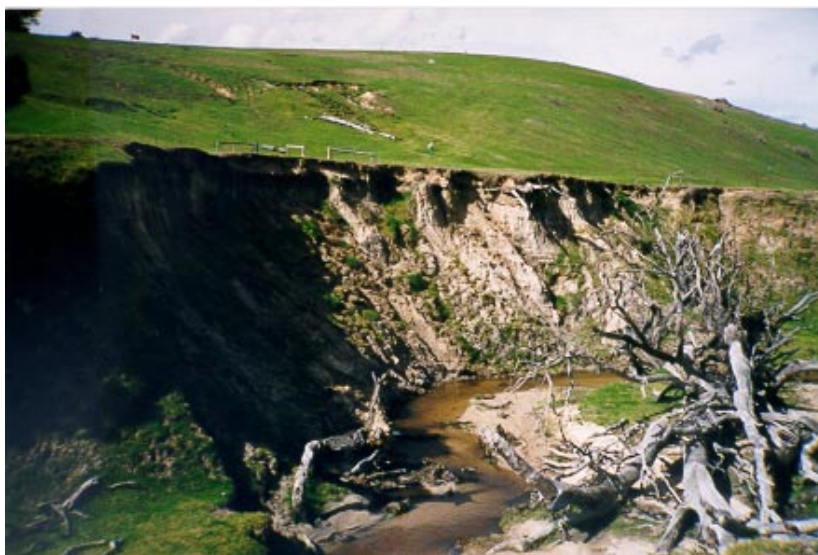
Fig. 4.4. Creightons Creek above the junction with Ramages Creek on Stan Artridge's property. This section of Creightons Creek has incised more than 10 m and anecdotal evidence suggests that most of this incision occurred during the 1916 flood.

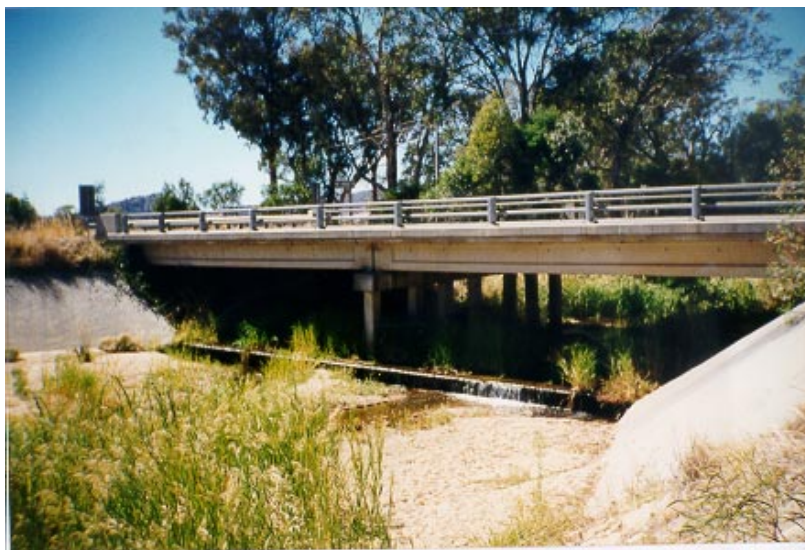
Fig. 4.5. Creightons Creek at the Hume Freeway Bridge. The concrete sill visible in the photo is a bed control structure that is protecting the bridge piers from being undermined.

The only evidence of stream incision downstream of Kellys Bridge during this period is at the present Hume Freeway where a highway bridge had to be replaced in 1957/8 because of stream enlargement (pers. comm. Paul Tucker, Vic Roads, Benalla, March 1998). A comparison of cross-sections measured on Creightons Creek at the Hume Freeway in 1957 and 1998 indicates that in that 40 year period the streambed at the bridge has dropped approximately 50 cm (Appendix Fig. B3). A bed control structure in the creek immediately below the bridge (Fig. 4.5) is holding another 30–50 cm erosion head from moving upstream. It is not possible to determine the timing of this incision.

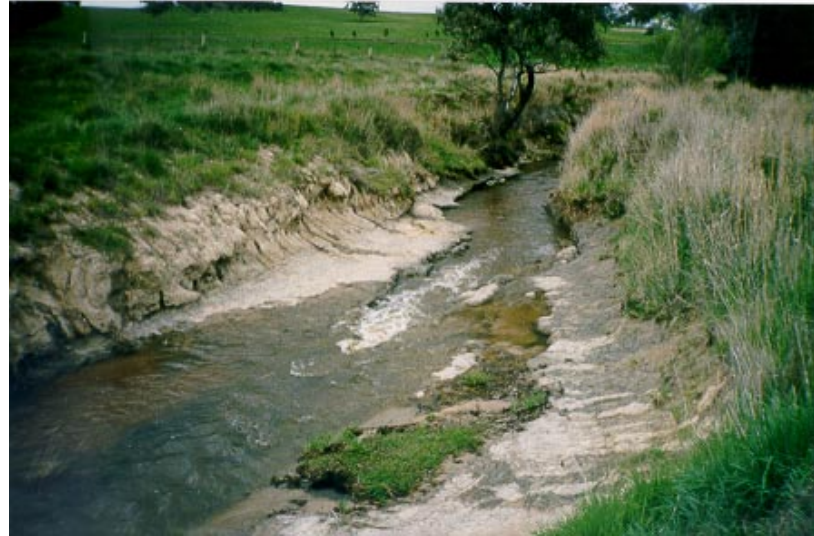
Fig. 4.6. Creightons Creek upstream of Bartons Lane.

This section of Creightons Creek would once have had a much smaller channel and would have flowed across a swampy plain. The stream is now incised and is continuing to incise in places (see headcut in channel bed).

Incision has also been noted upstream of Bartons Lane (Fig. 4.6.). Dino Furlanetto has noticed Creightons Creek incising over the last 25 years, with much of the incision occurring during flood events. The 1993 floods were particularly damaging, causing severe incision and widening immediately upstream of Bartons Lane, where the creek is now 3–4 m deep in places. To halt the incision Dino has put in two rock chutes to act as sediment traps. He claims they have caused the bed to rise about 3 feet (1 m), with most of the sediment being trapped within a year of chute construction (pers. comm. Dino Furlanetto, landholder, March 1998). It was interesting to note that the incision at the Furlanettos' has revealed the stumps of two large gum trees in the creek bed, suggesting that the creek has been at its current level in the past. This scenario is consistent with the filling and cutting of the creek bed at Kellys Bridge, 1–2 km further upstream, noted by Brian Kelly.

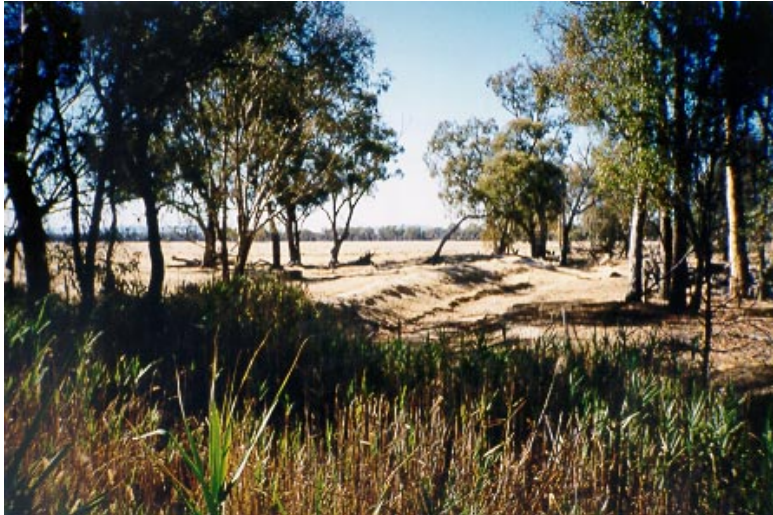
Fig. 4.7. A section of Creightons Creek upstream of the Longwood–Pranjip Rd. This section of channel was dredged in 1969 and the dredge material placed in mounds on the creek bank. Since the early 1970s the channel has only carried flood flows.

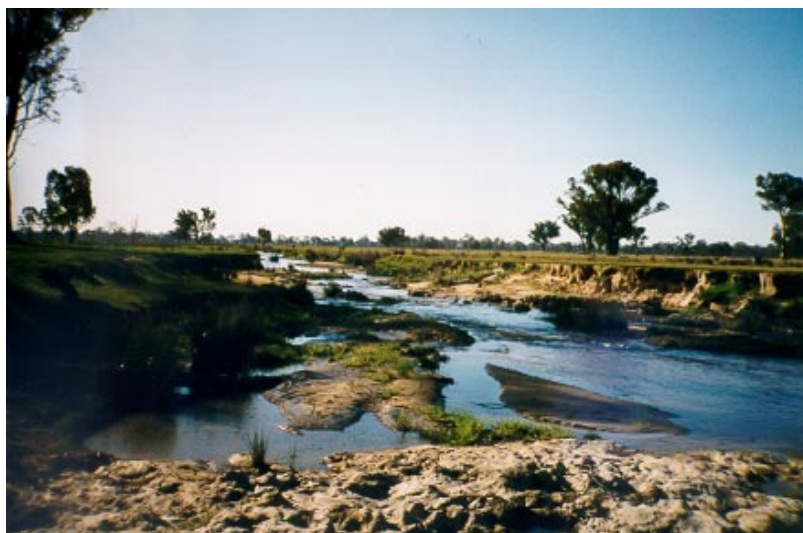
Fig. 4.8. Branjee Creek between Nelsons Rd and Drysdale Rd. This section of Branjee Creek was originally a narrow drain cut to divert all baseflows from Creightons Creek into Branjee Creek. The channel has deepened and widened substantially over the last 30 years.

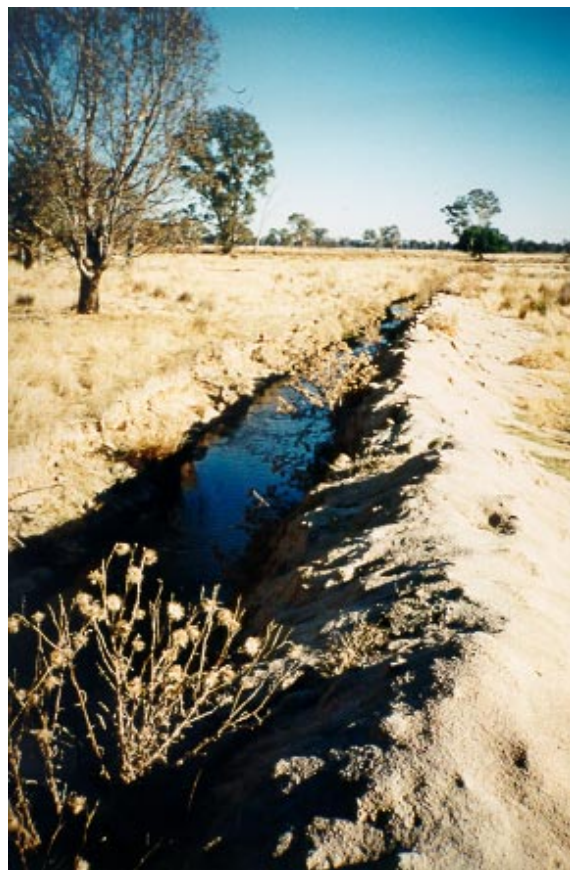
One notable example of erosion in Castle Creek catchment has been recorded in SCA, NRE and RWC Files, namely the movement of an 8 foot erosion head (2.4 m) up Castle Creek during the 1970s. According to an SCA report between 1973 and 1977 the head advanced 80 m upstream, degrading the bed 2.5 m and widening the stream 5–15 m (S/1064). It is interesting to consider this rate of advance in relation to rainfall in this period. Annual rainfall in 1973 was 1078 mm, the wettest year since records began. This was followed by 897 mm in 1974 and 896 mm in 1975 (based on rainfall data in the Centenary Edition of the *Euroa Gazette*, 1997). The SCA report does not reveal what initiated the erosion head/s, but it indicates that the wet 1970s led to the rapid liberation of approximately 2000 m³ of sediment from the bed and banks of Castle Creek.

The NRE/RWC Files for Castle Creek indicate that the 8 foot erosion head that moved through the upper reaches of Castle Creek in the 1970s incised a section of creek that had already been incised 10 feet (3 m) in 1961 (NRE/RWC File, 62/19071). Anecdotal evidence from a local landholder suggests that this reach of Castle Creek, i.e. above Killeens Hill Rd, was quite stable and relatively undisturbed until the 1960s when his father decided to move the creek so it was closer to the house for convenience (pers. comm. Geoff McLean, landholder, May 1998). He did this by using his tractor to dig a new channel for the creek, and he succeeded in diverting the creek over a length of 500 m. However, once the creek changed course it began to incise. On the McLean's property there have been two periods of incision, the first coinciding with the diversion of the creek in the 1950s–60s, and the second in response to the 1993 floods. Both periods of incision have reduced the bed elevation by about 2 m. The erosion head initiated by the diversion of the creek in the 1950s–60s migrated upstream until it reached a waterfall (several kilometres above the McLean's property). It appears that as the head migrated upstream it increased in height, incising into the streambed more deeply, and in fact it appears that the head has incised into the original creek bed up to 10 m, just below the waterfall (Fig. 4.10).

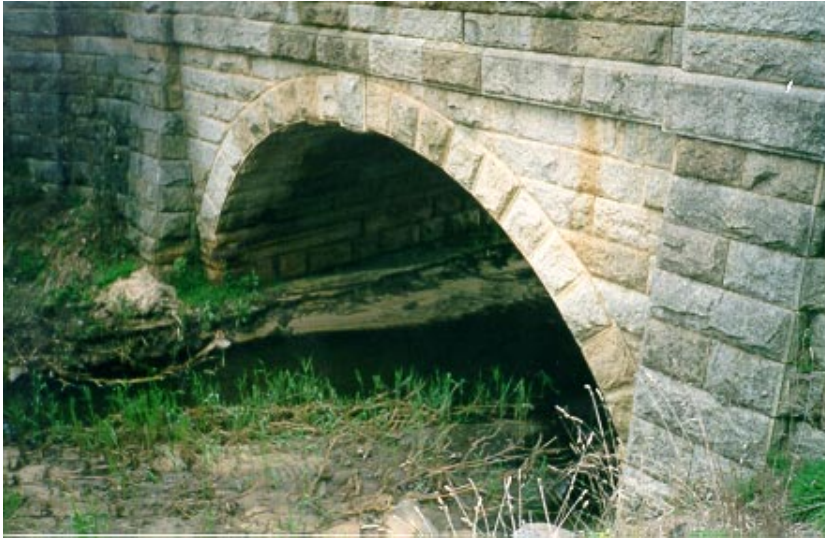
Fig. 4.12. Pranjip Creek at the Hume Freeway. More than 0.5 m of sediment may have been deposited in this section of channel between 1958 and 1998.

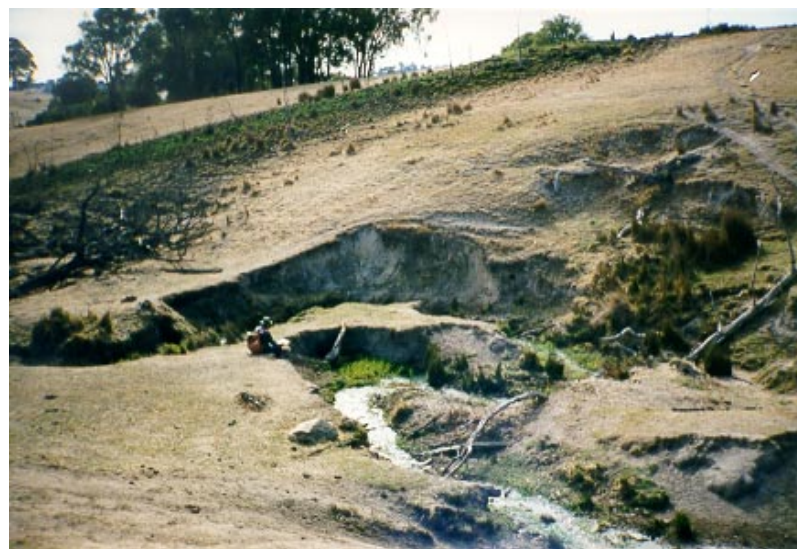
Fig. 4.14. Creightons Creek upstream of the Creightons Creek Rd. This photo shows examples of both on-stream (stream bank) and off-stream (natural spring discharge site) damage caused by stock.

Stocking can have two impacts (e.g. Fig. 4.14). Away from drainage lines, hooved animals have the capacity to compact soils and reduce vegetative cover, which can increase runoff rates and erosion potential. Along drainage lines, stock can potentially do far more damage, particularly when stocking rates are not managed appropriately. Stock can damage vegetation that has an important stabilising role along a drainage line, and also initiate erosion. Stock paths through drainage lines can form points of flow concentration and thus erosion heads. Stock, particularly heavier animals such as cattle, can also break down stream banks. A study in the USA found that uncontrolled grazing along streams by cattle caused six times as much bank erosion as was measured at ungrazed sites, due mainly to the trampling of banks by stock (Trimble 1994). The study concluded that uncontrolled grazing of streambanks in the eastern United States has played an important role in stream widening during historical time.

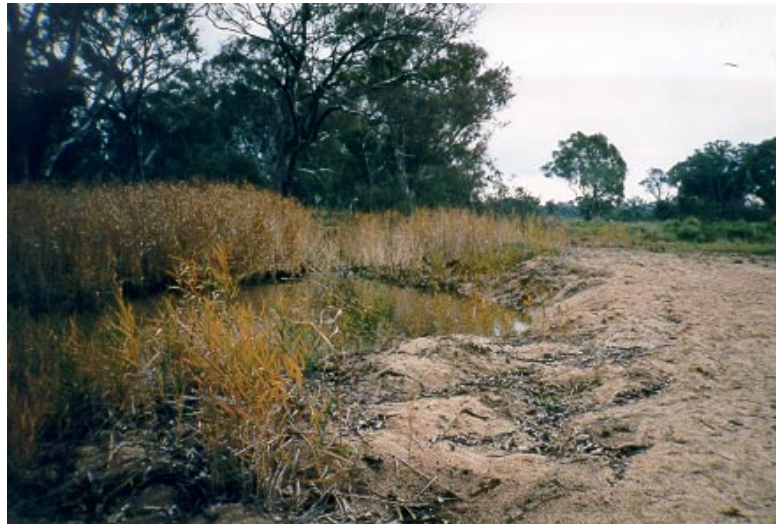
Fig. 4.15. A sand pit on Castle Creek downstream of the old Hume Highway Bridge. Sand has been extracted from this site in the past.
