Sand Slugs and Stream Degradation: The Case of the Granite Creeks, North-east Victoria

Cooperative Research Centre for Freshwater Ecology
Technical Report 7/2000
December 2000

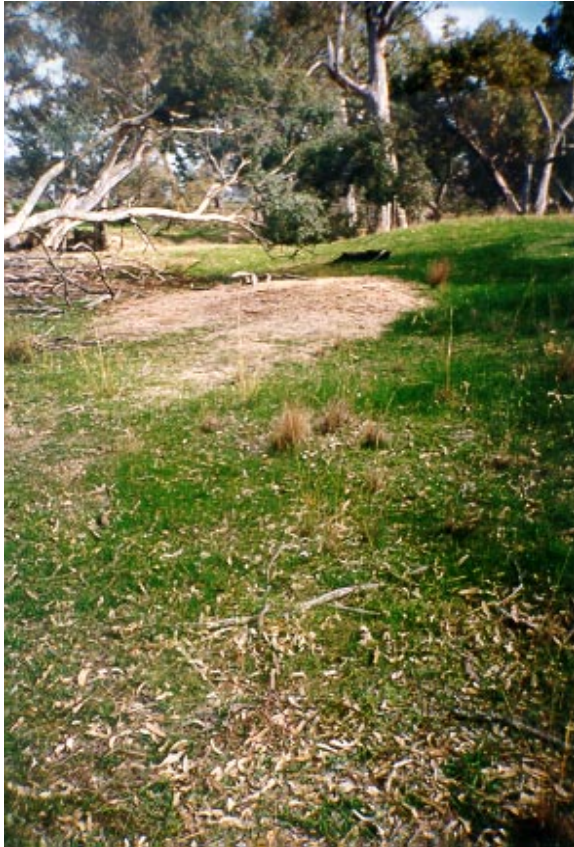
Fig. 3.4. An example of a high-level sand drape

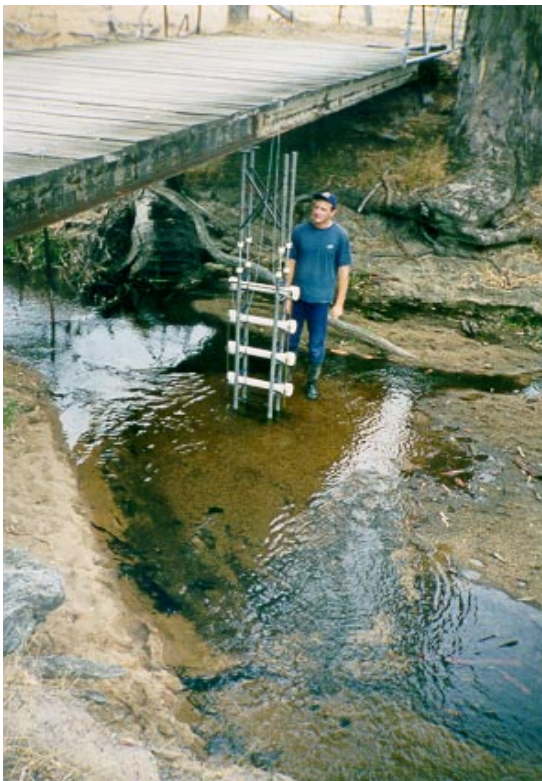
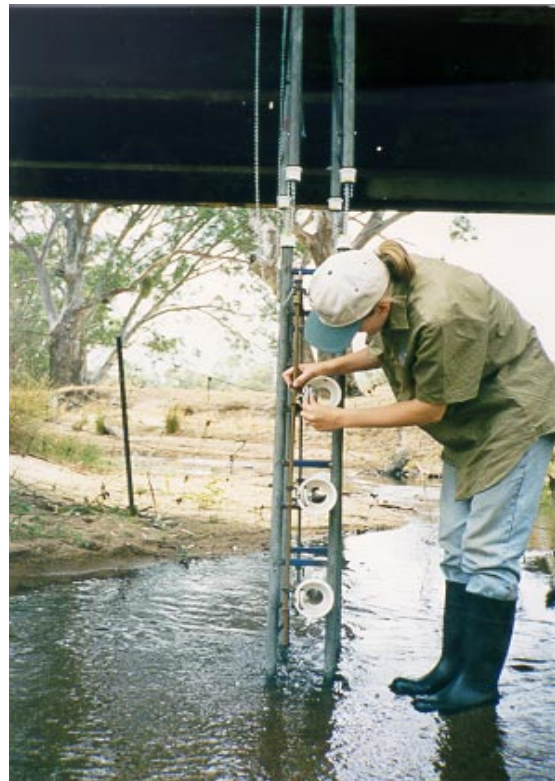
Fig. 3.6. Two views of the suspended sediment sampler

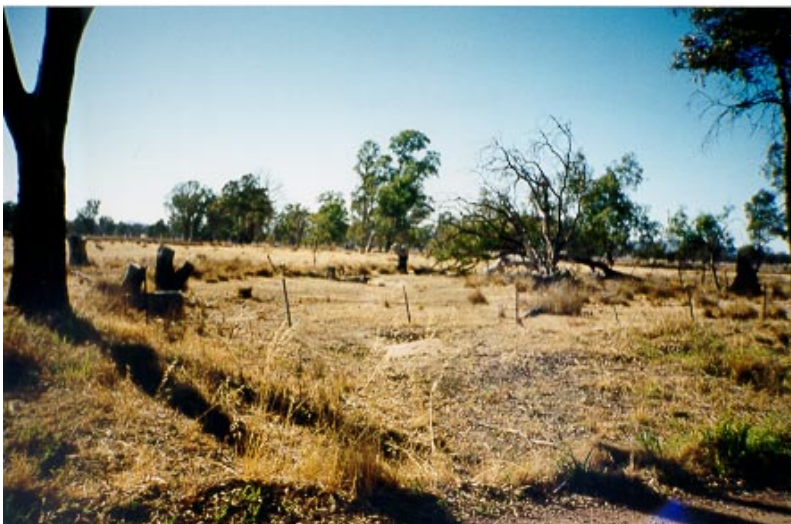
Fig. 4.2. Former channel of Creightons Creek upstream of Geodetic Rd. Anecdotal evidence suggests that a deep pool (2–3 m deep) existed at this point towards the end of the 19th century.

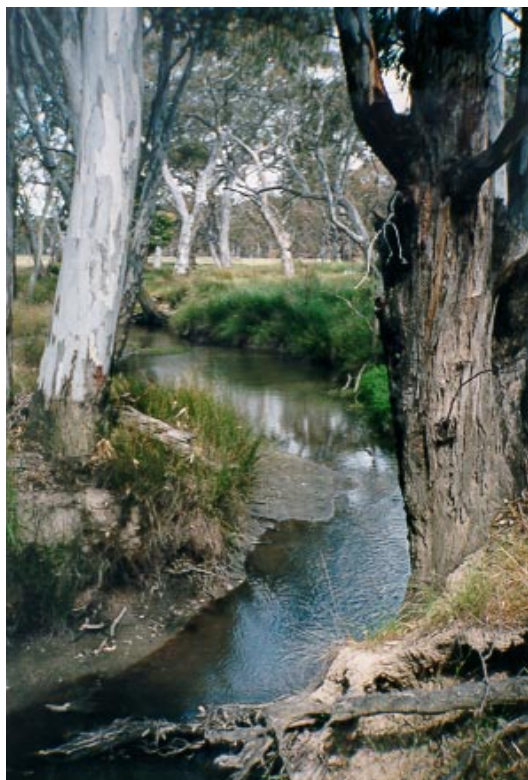
Fig. 4.3. Remnant pools on Creightons Creek today. This stream form could be representative of the lower reaches of Creighton's Creek (i.e. below the present Hume Freeway) in the 1800s.

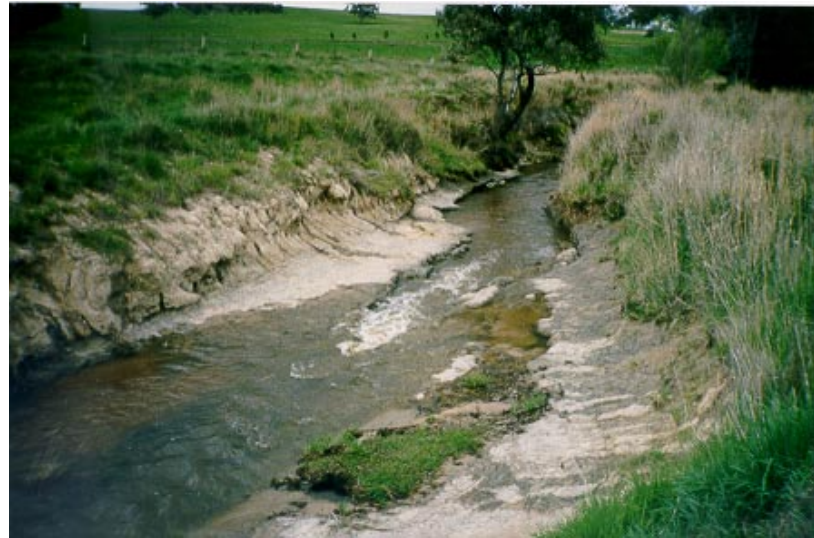
This section of Creightons Creek would once have had a much smaller channel and would have flowed across a swampy plain. The stream is now incised and is continuing to incise in places (see headcut in channel bed).

Incision has also been noted upstream of Bartons Lane (Fig. 4.6.). Dino Furlanetto has noticed Creightons Creek incising over the last 25 years, with much of the incision occurring during flood events. The 1993 floods were particularly damaging, causing severe incision and widening immediately upstream of Bartons Lane, where the creek is now 3–4 m deep in places. To halt the incision Dino has put in two rock chutes to act as sediment traps. He claims they have caused the bed to rise about 3 feet (1 m), with most of the sediment being trapped within a year of chute construction (pers. comm. Dino Furlanetto, landholder, March 1998). It was interesting to note that the incision at the Furlanettos' has revealed the stumps of two large gum trees in the creek bed, suggesting that the creek has been at its current level in the past. This scenario is consistent with the filling and cutting of the creek bed at Kellys Bridge, 1–2 km further upstream, noted by Brian Kelly.

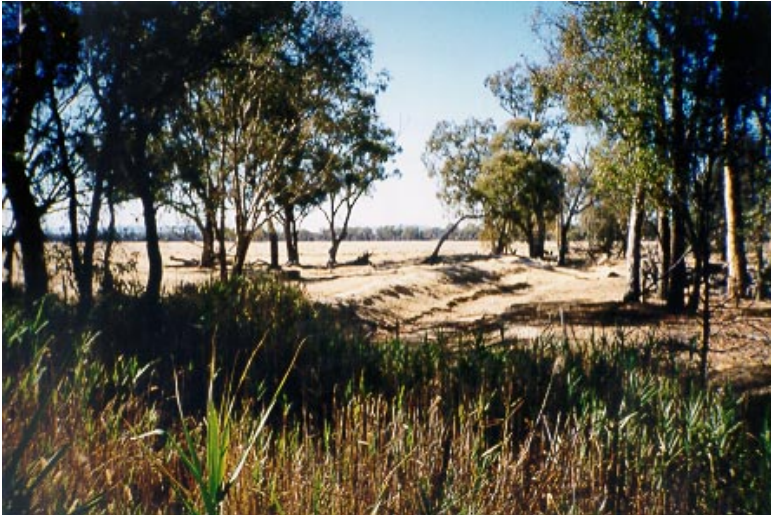
Fig. 4.7. A section of Creightons Creek upstream of the Longwood–Pranjip Rd. This section of channel was dredged in 1969 and the dredge material placed in mounds on the creek bank. Since the early 1970s the channel has only carried flood flows.

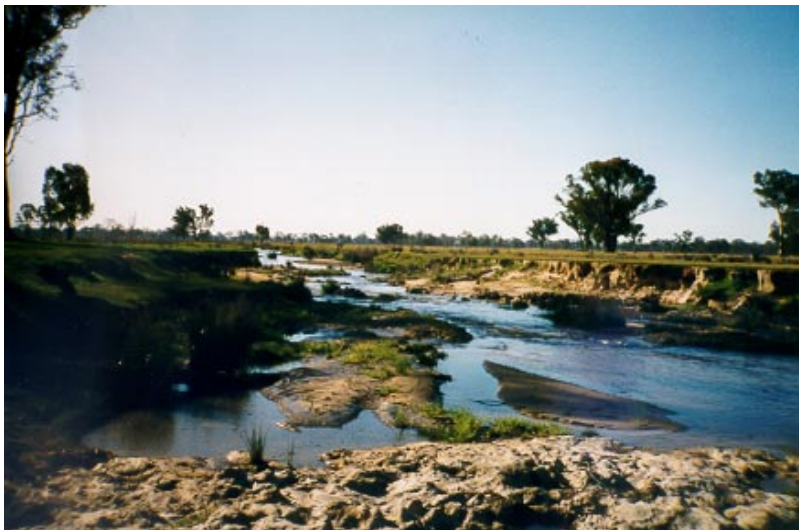
Fig. 4.8. Branjee Creek between Nelsons Rd and Drysdale Rd. This section of Branjee Creek was originally a narrow drain cut to divert all baseflows from Creightons Creek into Branjee Creek. The channel has deepened and widened substantially over the last 30 years.

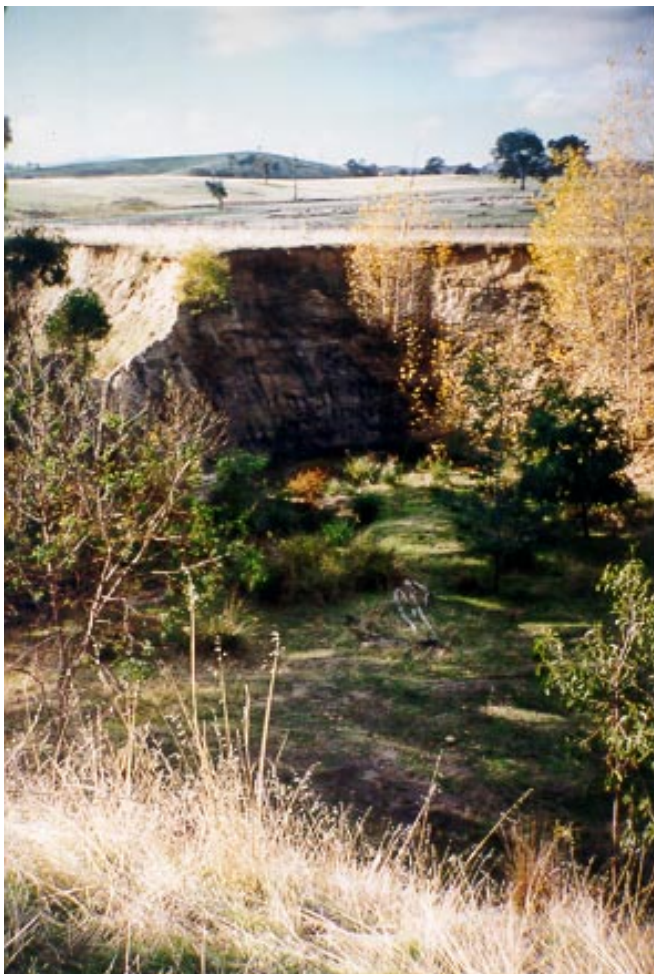
Fig. 4.10. Castle Creek upstream of the McLeans' property. Severe stream incision and widening has led to the formation of this chasm since the 1960s.

The NRE/RWC Files for Castle Creek indicate that the 8 foot erosion head that moved through the upper reaches of Castle Creek in the 1970s incised a section of creek that had already been incised 10 feet (3 m) in 1961 (NRE/RWC File, 62/19071). Anecdotal evidence from a local landholder suggests that this reach of Castle Creek, i.e. above Killeens Hill Rd, was quite stable and relatively undisturbed until the 1960s when his father decided to move the creek so it was closer to the house for convenience (pers. comm. Geoff McLean, landholder, May 1998). He did this by using his tractor to dig a new channel for the creek, and he succeeded in diverting the creek over a length of 500 m. However, once the creek changed course it began to incise. On the McLean's property there have been two periods of incision, the first coinciding with the diversion of the creek in the 1950s–60s, and the second in response to the 1993 floods. Both periods of incision have reduced the bed elevation by about 2 m. The erosion head initiated by the diversion of the creek in the 1950s–60s migrated upstream until it reached a waterfall (several kilometres above the McLean's property). It appears that as the head migrated upstream it increased in height, incising into the streambed more deeply, and in fact it appears that the head has incised into the original creek bed up to 10 m, just below the waterfall (Fig. 4.10).

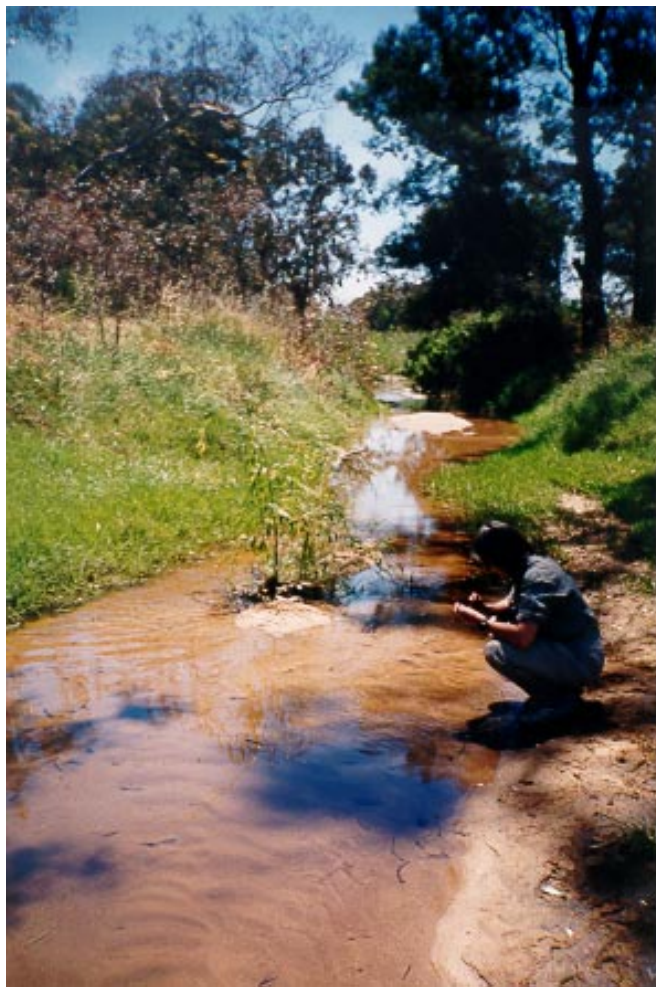
Fig. 4.11. Sand deposition in Castle Creek downstream of the old Hume Highway Bridge

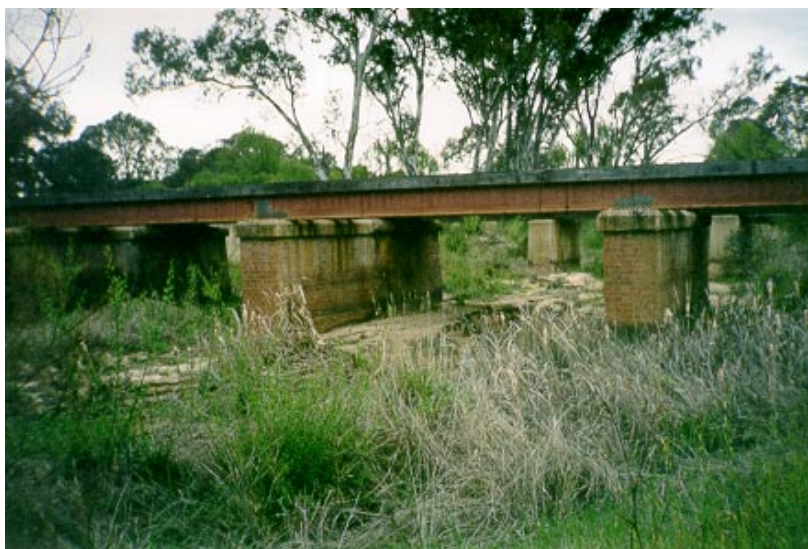
Fig. 4.13. Pranjip Creek at the railway line (Pranjip West Bridge). The stream bed in this vicinity has aggraded and degraded during the period since European settlement.

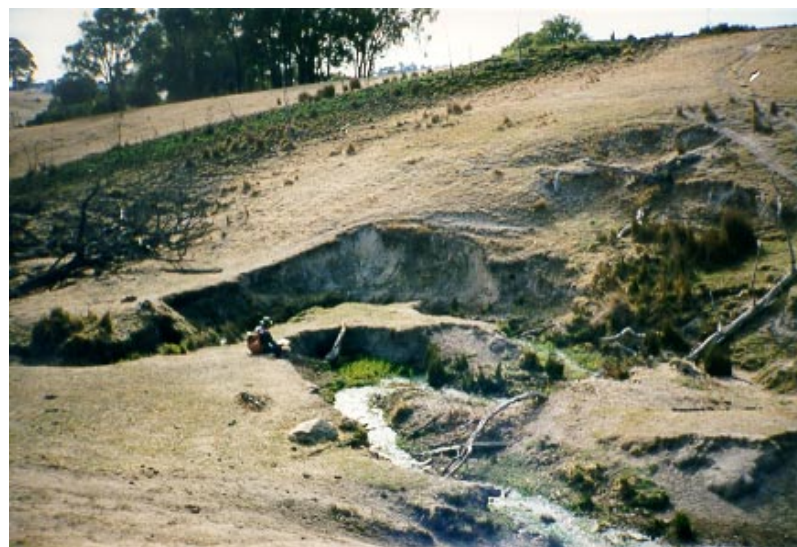
Fig. 4.14. Creightons Creek upstream of the Creightons Creek Rd. This photo shows examples of both on-stream (stream bank) and off-stream (natural spring discharge site) damage caused by stock.

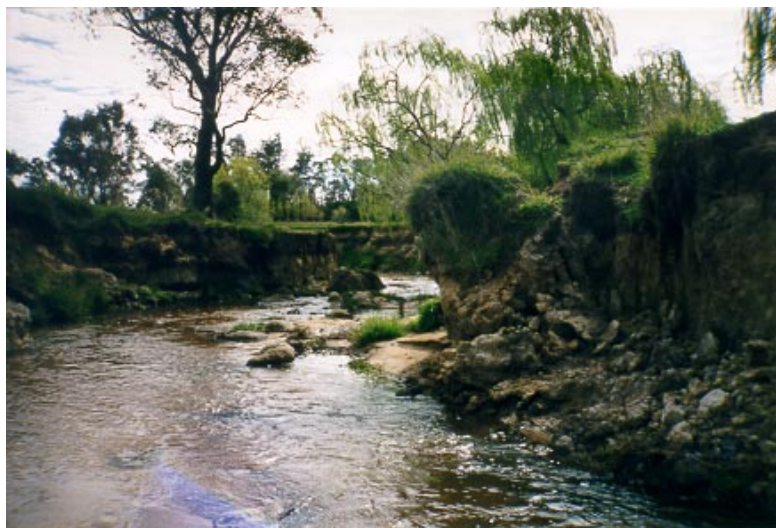
Fig. 5.3. Eroding stream-banks in the middle reaches of Creightons Creek

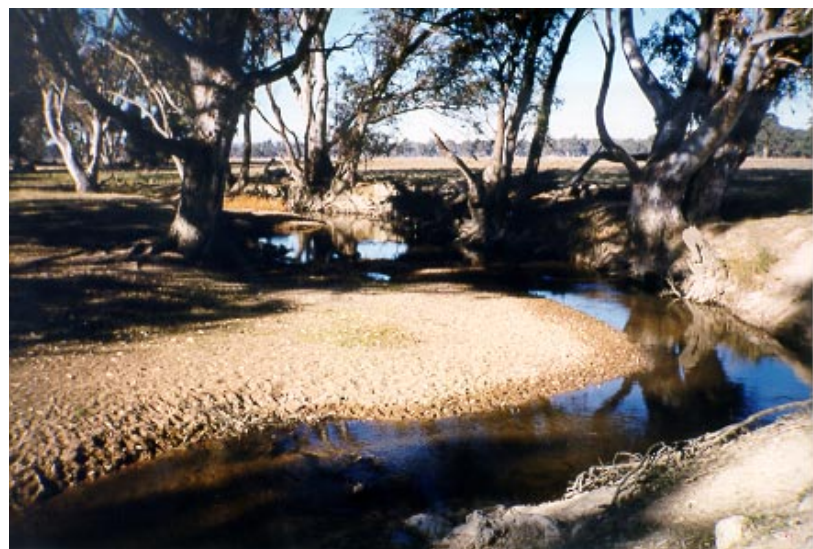
Fig. 5.11. A partially sanded reach of Creightons Creek

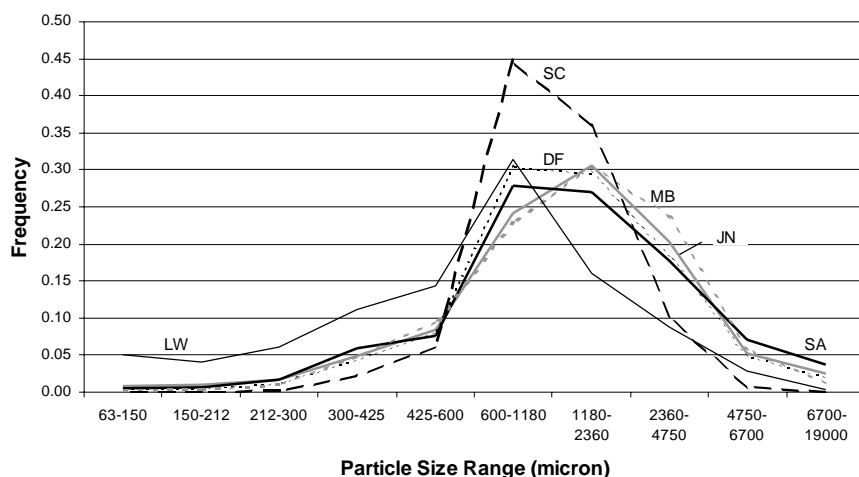
Fig. 5.19. Summary of average creek bed histograms

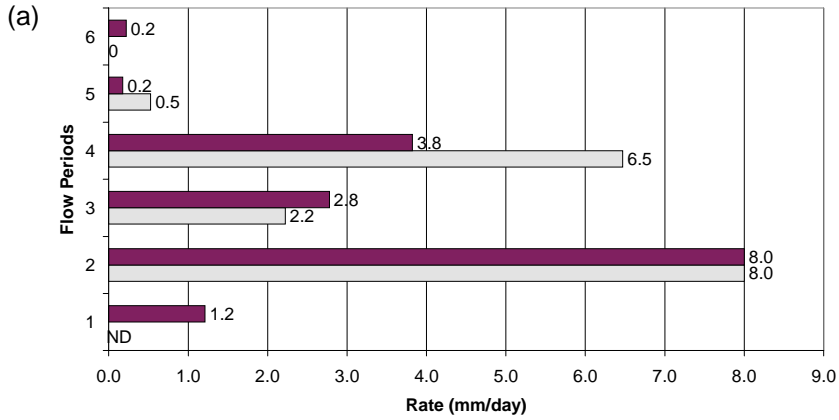
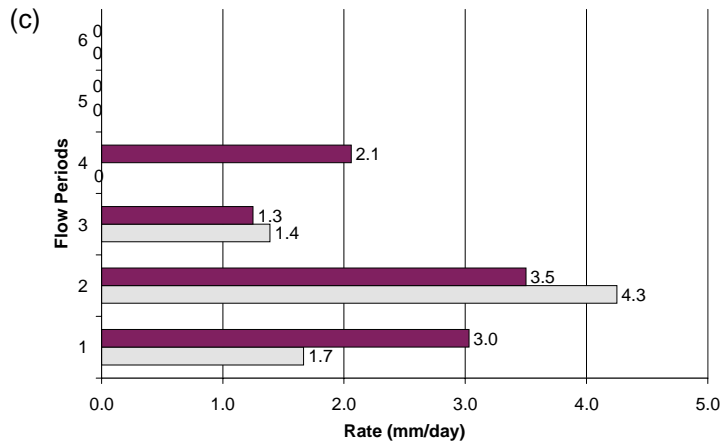
Fig. 5.21. Scour chain data for Castle Creek, showing scour (pale bars) and deposition (dark bars) in mm/day:

(a) Bamford Chain 1;

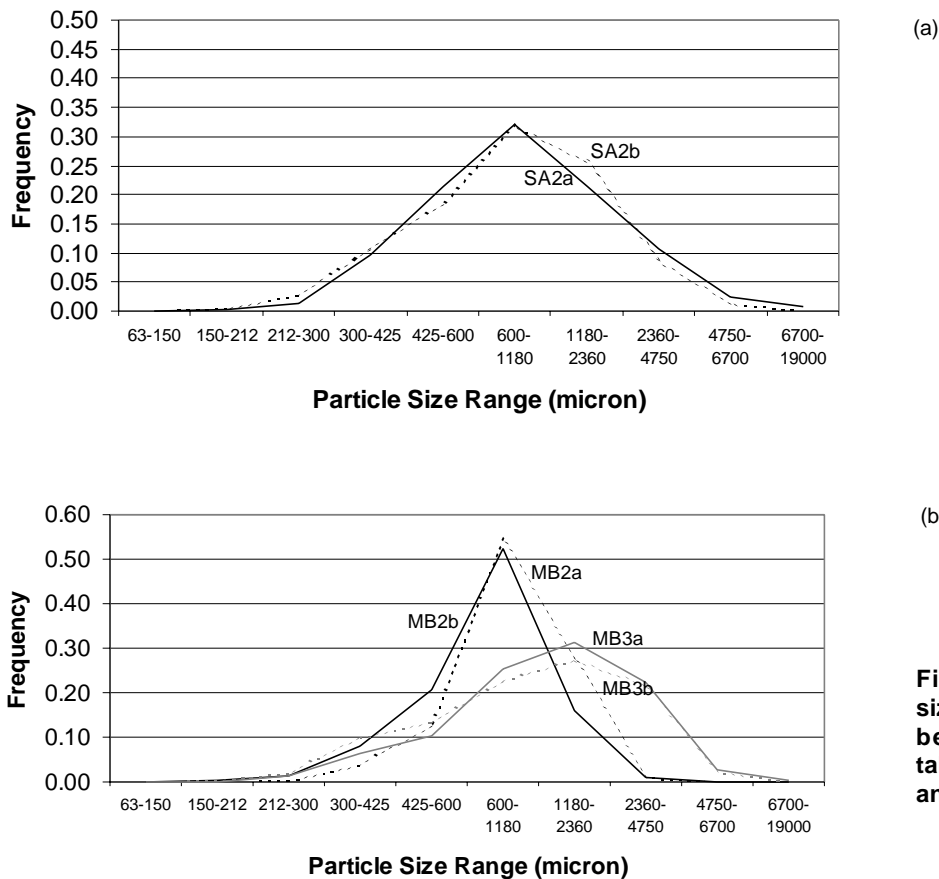
Fig. 5.25. Particle size distributions of bedload samples taken at (a) site SA and (b) site MB

observation suggests that at a given site on a cross-section, under a steady discharge, particle size distributions are consistent regardless of variations in the rate of bedload transport. However, a comparison of particle size distributions taken at different sites on a cross-section under the same discharge indicates that particle size distributions can vary significantly across the bed (Fig 5.25b).

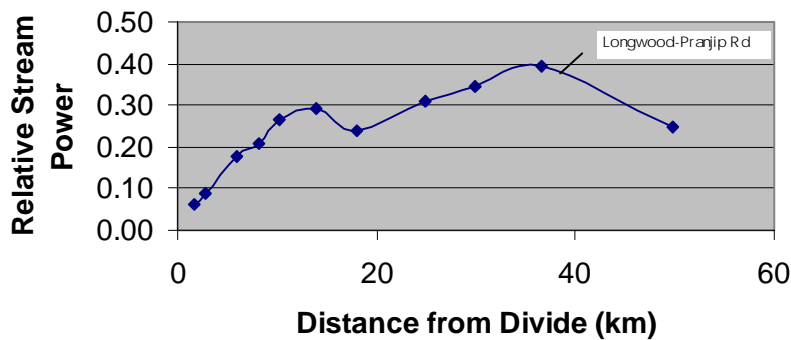
Fig. 6.1. Relative stream power vs stream length
