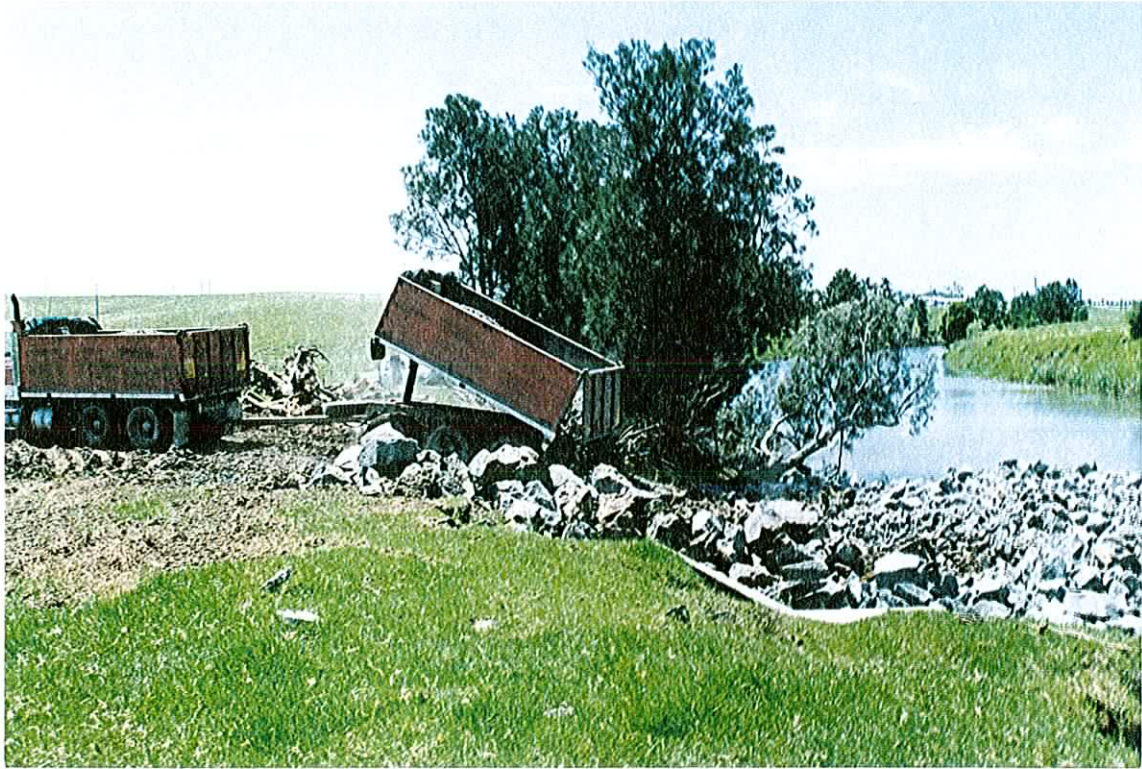
**Photograph 1.** Dumping of rock on site during construction of a rock-ramp fishway on McDonald's Weir, Macquarie Rivulet in January 1993.

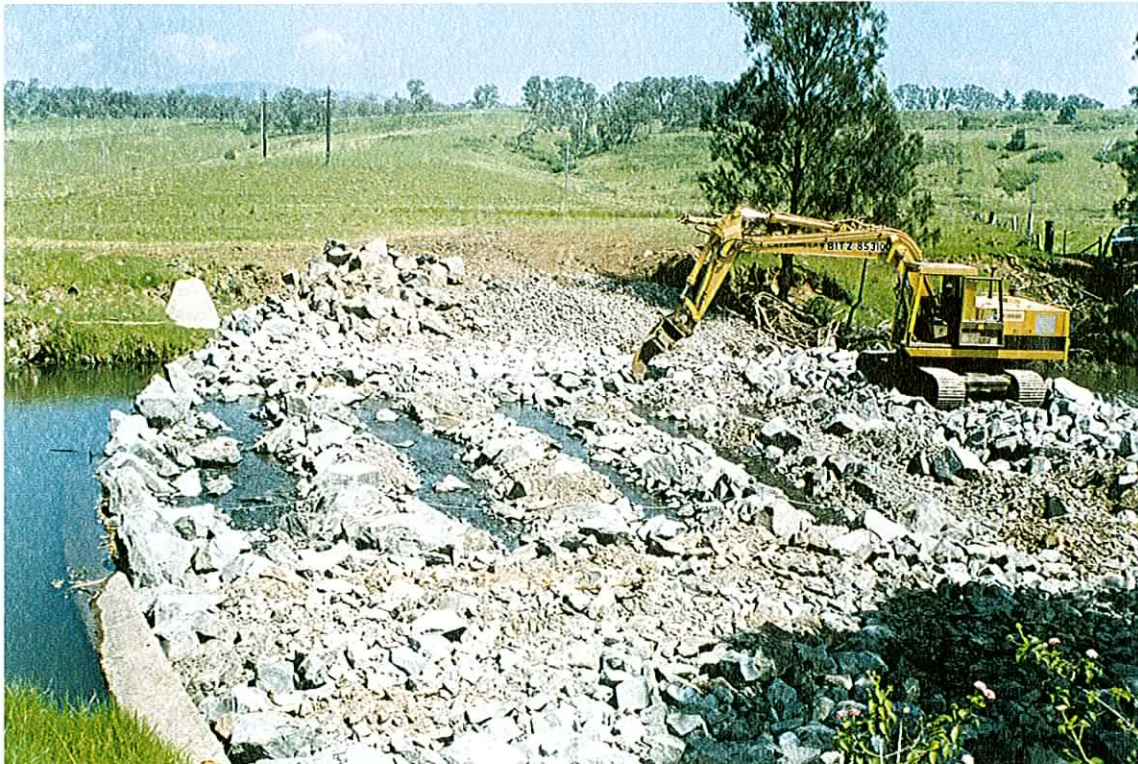
**Photograph 2.** Shaping transverse rock ridges during construction of a rock-ramp fishway on McDonald's Weir, Macquarie Rivulet.

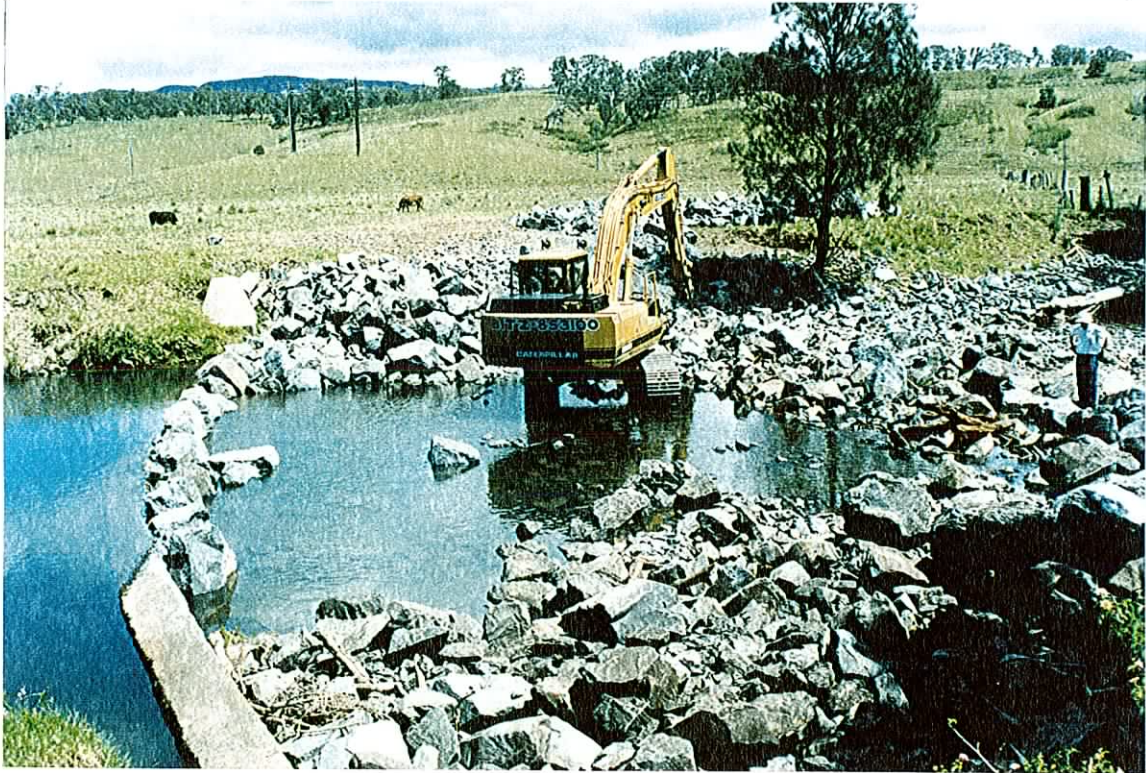
**Photograph 3.** Modifications to McDonald's Weir Rock-ramp Fishway to repair damage caused by high flows. (Note the larger rocks being placed next to the weir crest)

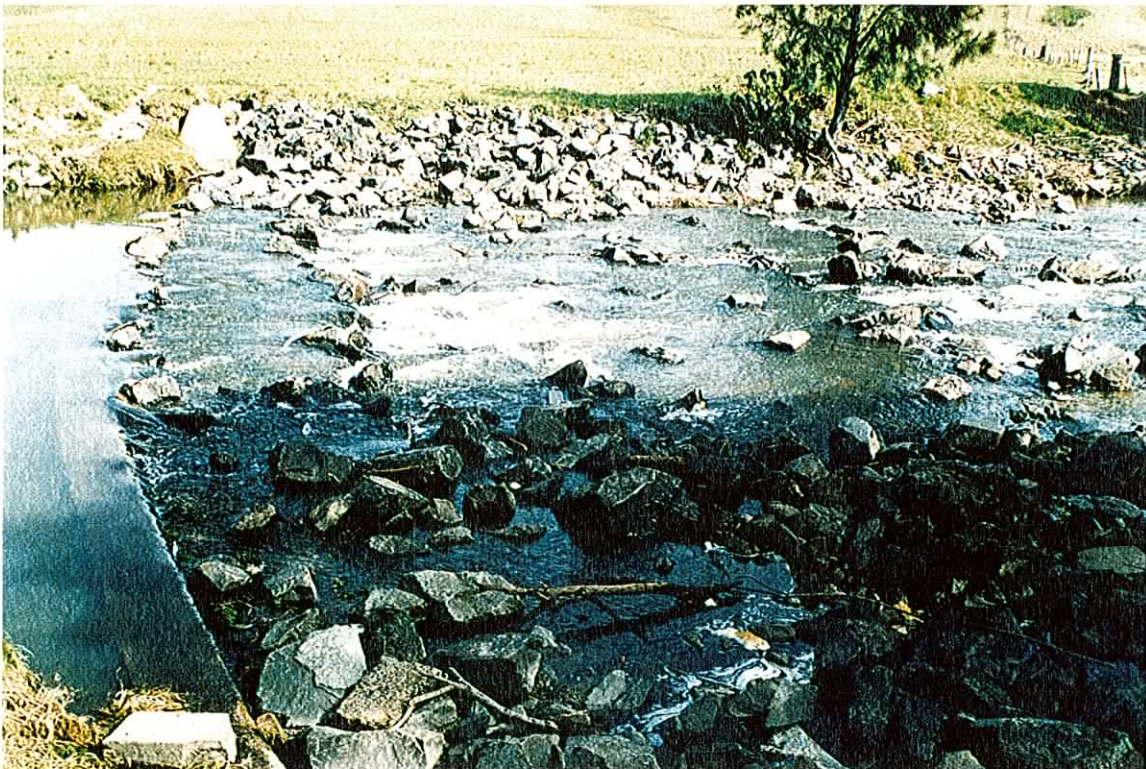
**Photograph 4.** After modifications to the McDonald's Weir Rock-ramp Fishway. (Note the movement of the transverse ridge rocks in the middle of the structure)

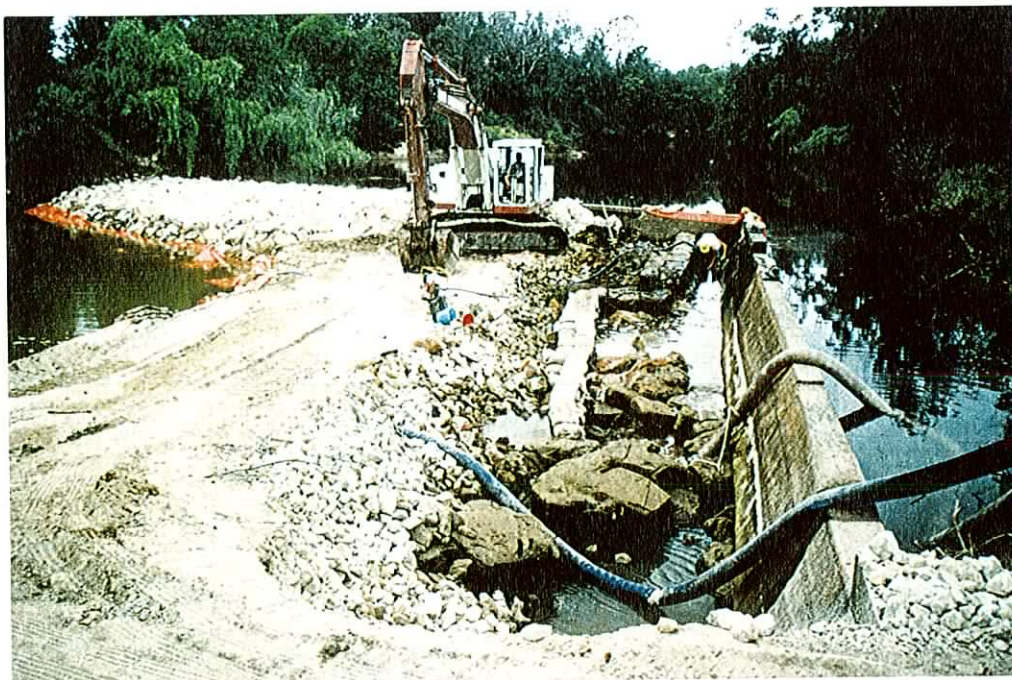
**Photograph 5.** The placement of rocks below the Lower Wyong Weir, Wyong River to prevent water leakage through the existing concrete structure.

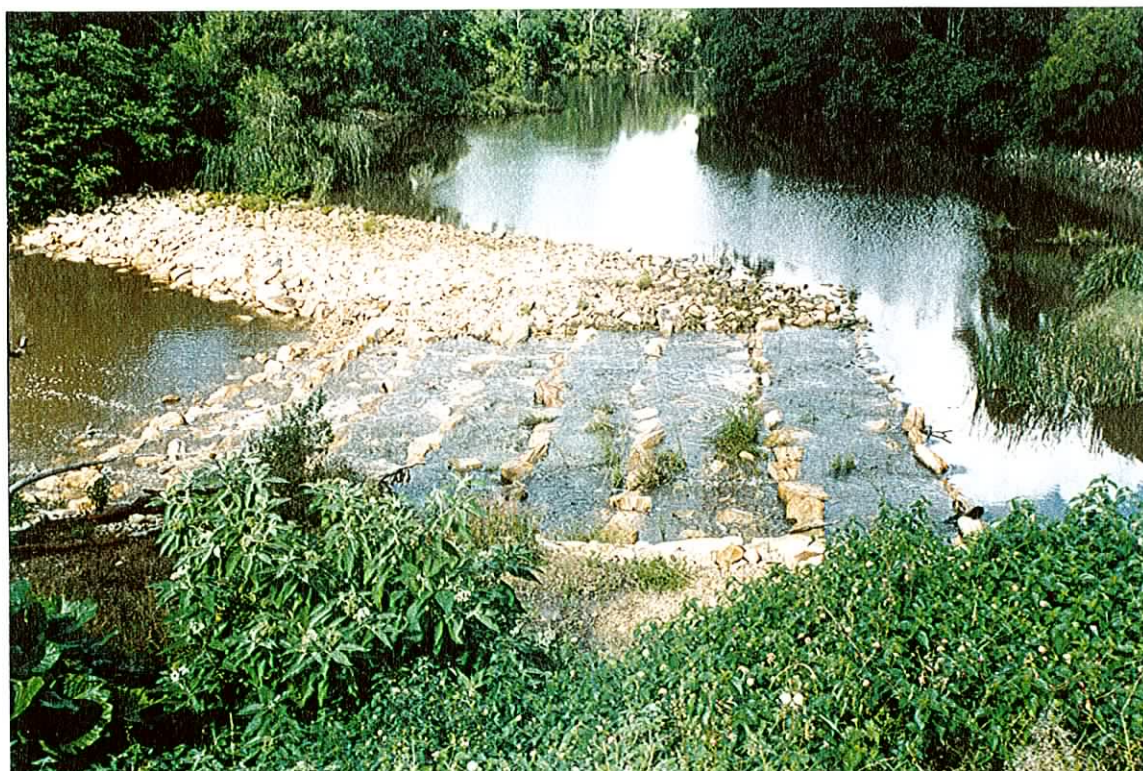
**Photograph 6.** In September 1993 extra rock was placed below the Lower Wyong Weir and a rock-ramp fishway formed. (Note the lower weir crest in the foreground)

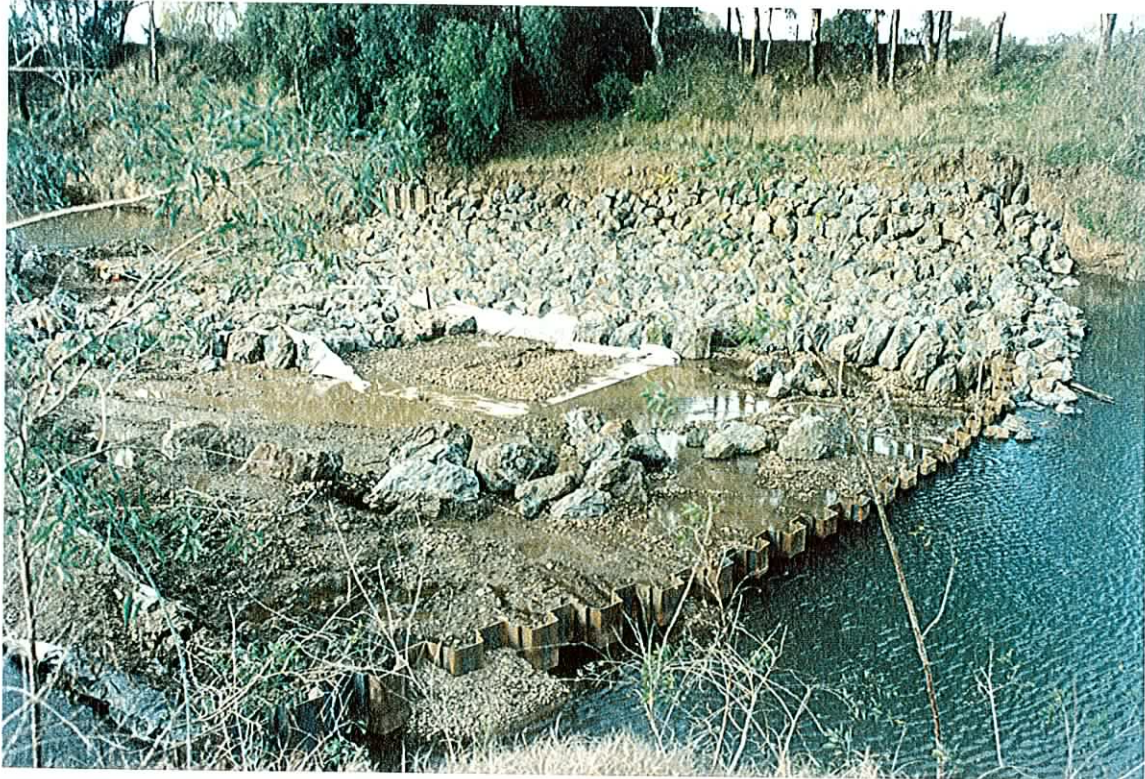
**Photograph 7.** The construction of an erosion control weir on the Bell River in June 1993. (Note the sheet-pile wall and the placement of large rocks)

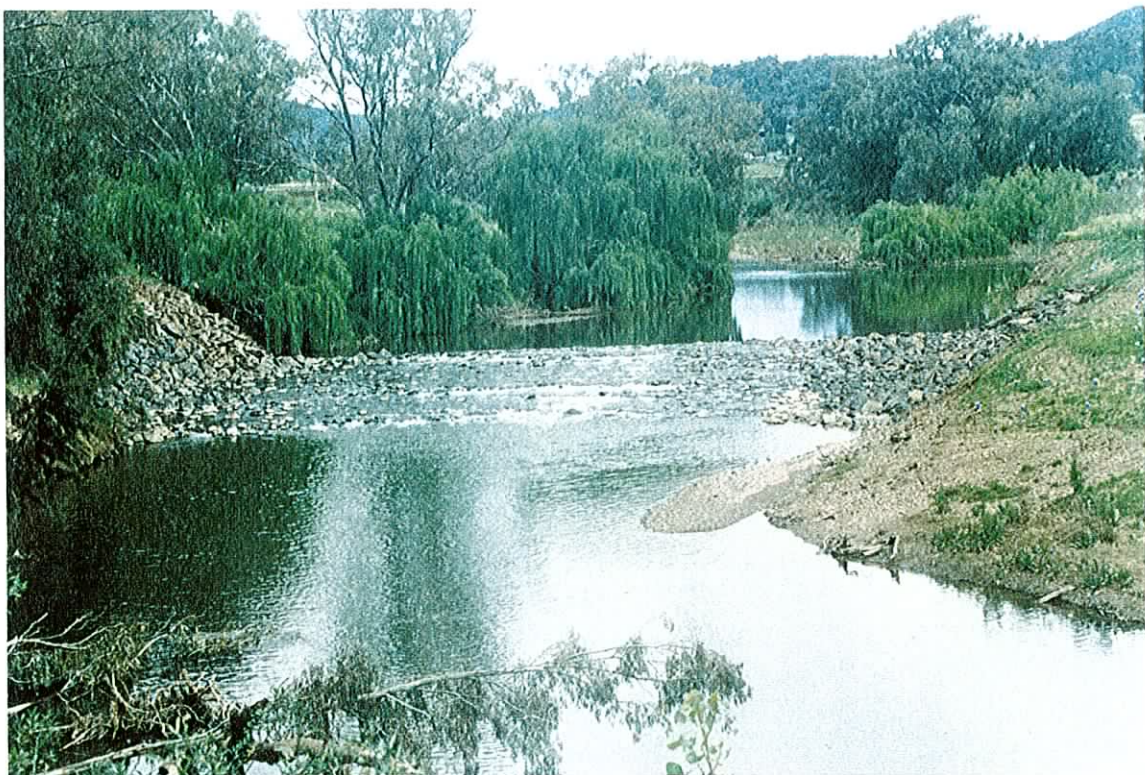
**Photograph 8.** After construction of the erosion control weir on the Bell River. (Note the rock-ramp fishway was formed in the centre of the structure)

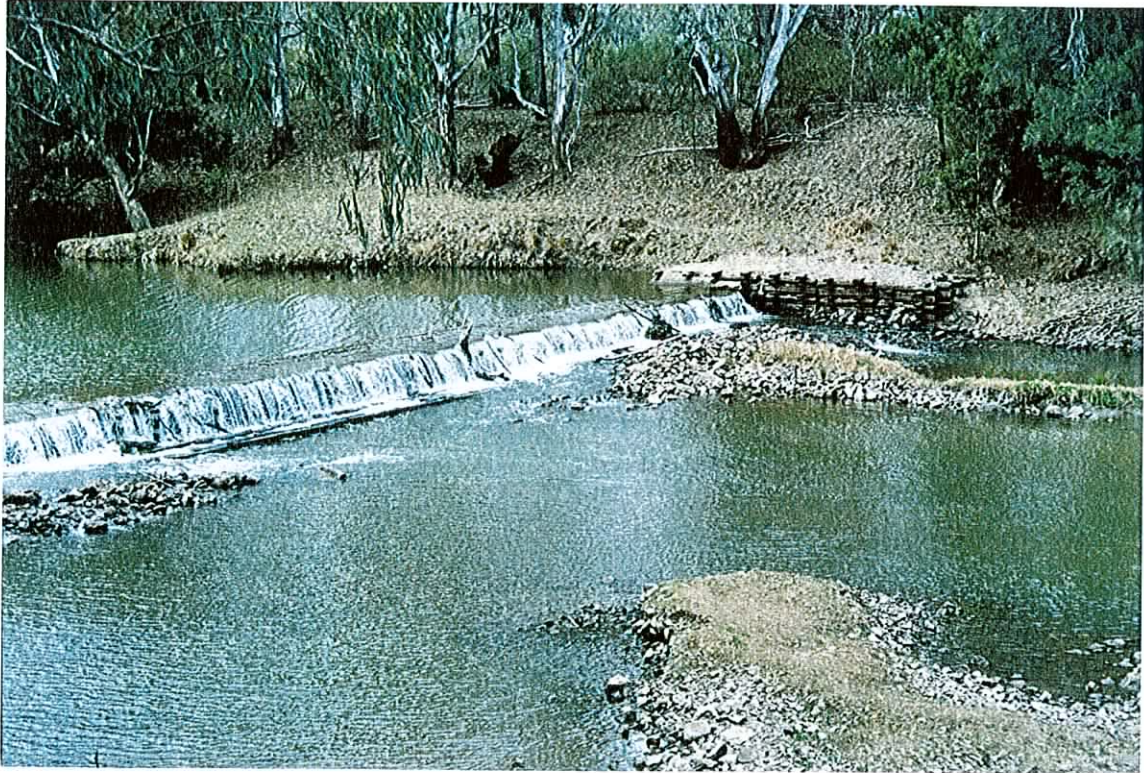
**Photograph 9.** The original wood-and-concrete weir at Goondiwindi on the Macintyre River before the construction of a rock-ramp in August 1993.

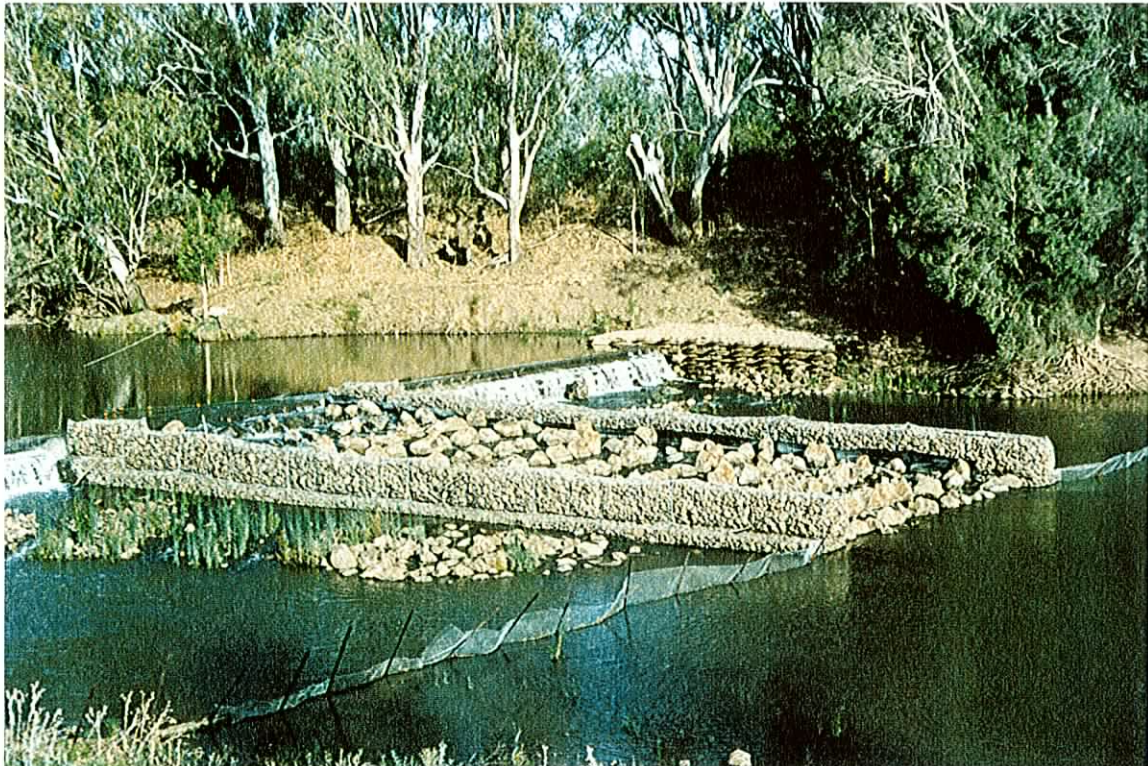
**Photograph 10.** The rock-ramp down the centre of the river with crests on each side of the channel raised to direct water through the fishway. (Note the guiding fence)

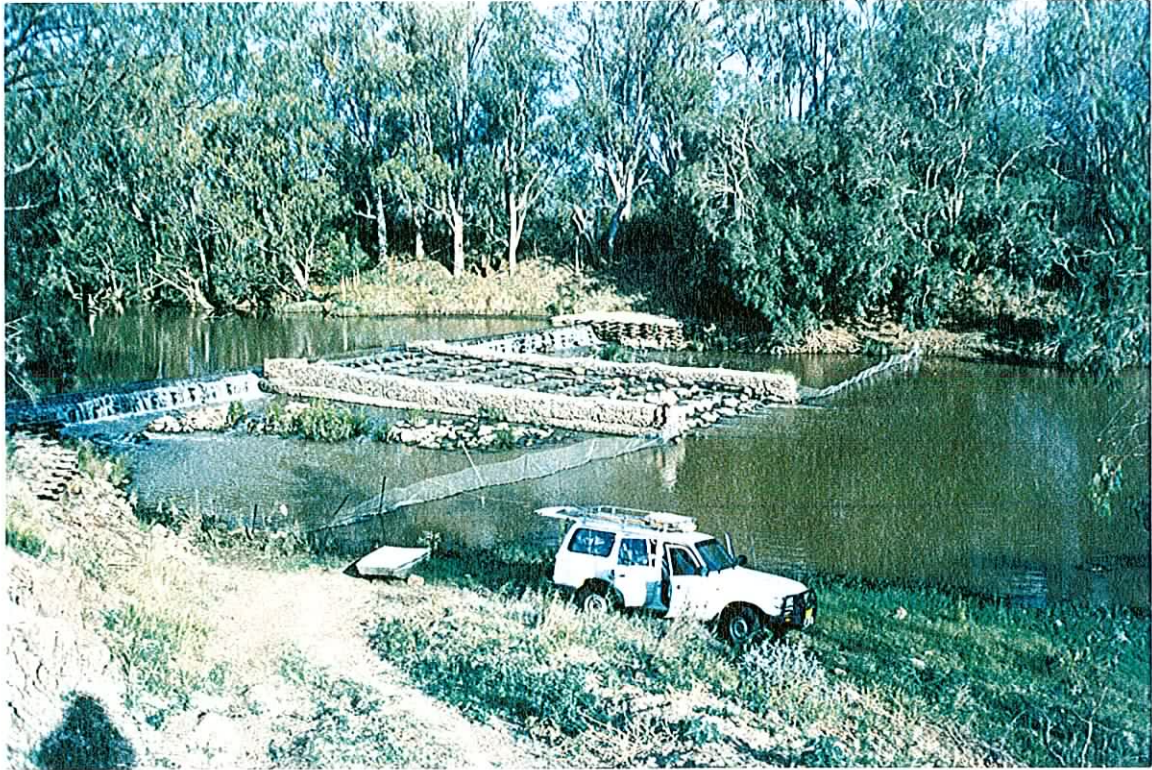
**Photograph 11.** Goondiwindi Weir and Fishway during sampling on 4 November 1995 with flows greater than 600 ML/day. (Note flow over side crests)

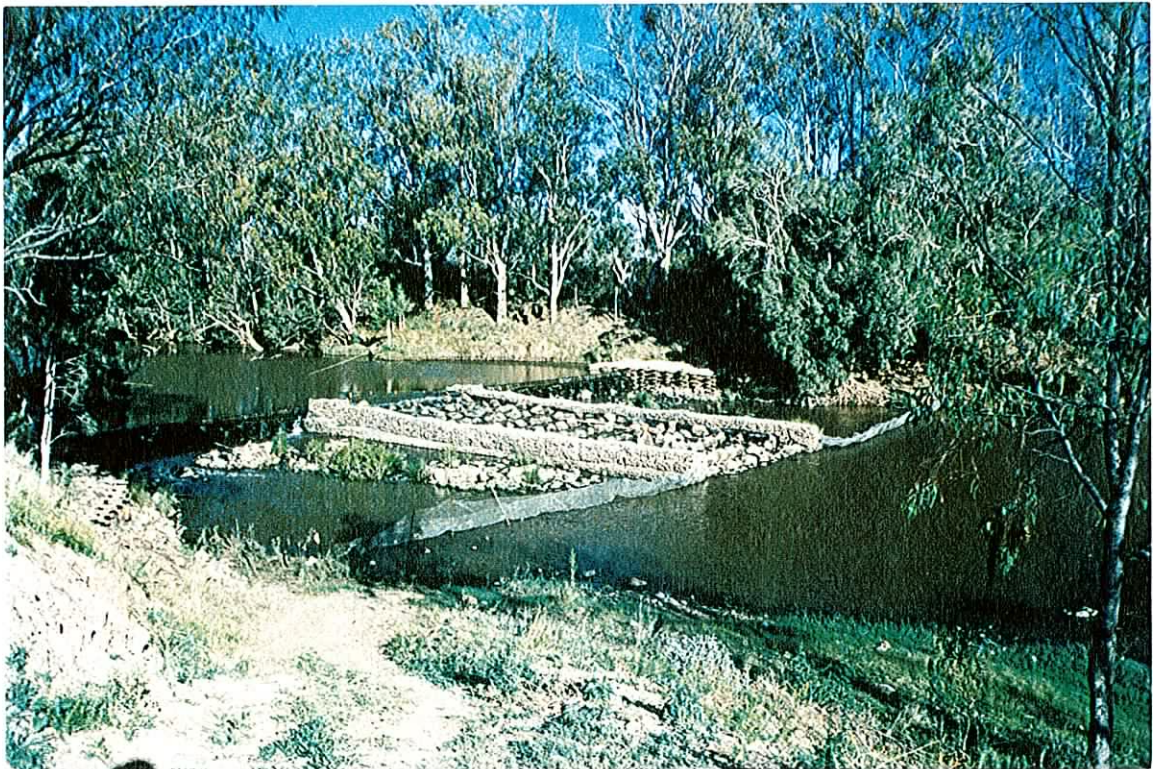
**Photograph 12.** Goondiwindi Weir and Fishway during sampling on 7 November 1995 with flows less than 300 ML/day. (Note lack of flow over side crests)

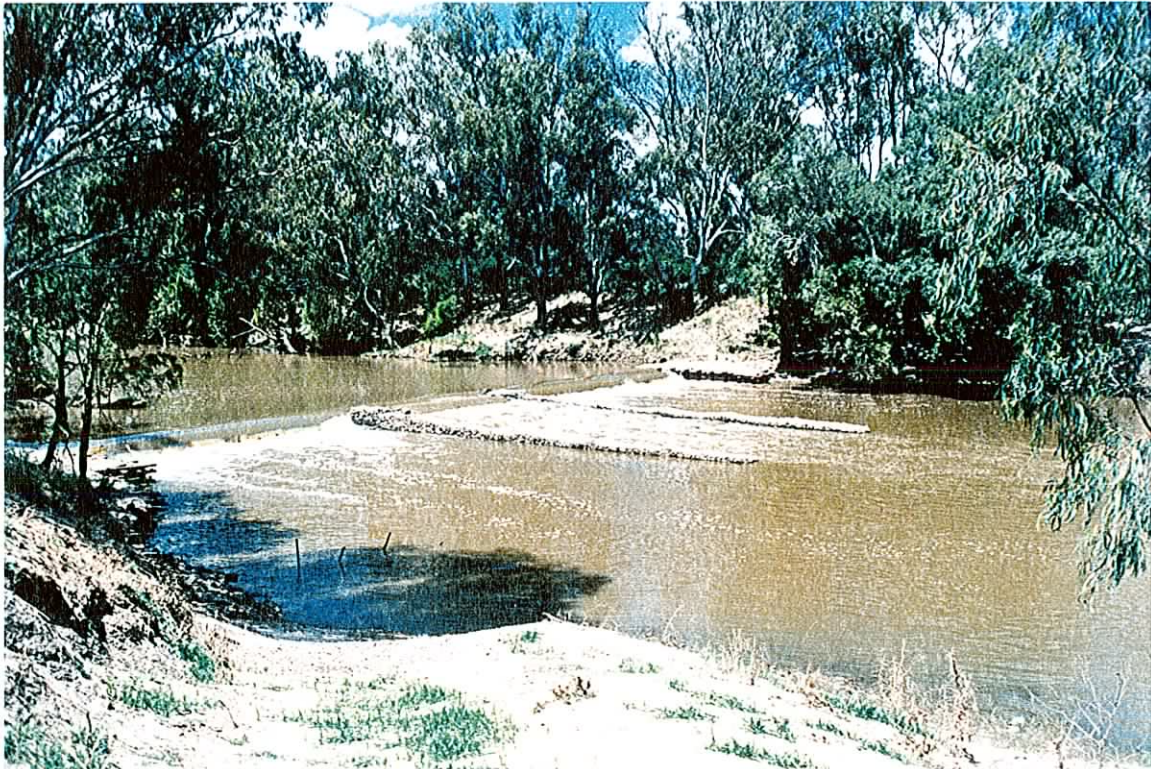
**Photograph 13.** Goondiwindi Weir and Fishway with 900 ML/day flow down the Macintyre River in March 1996.

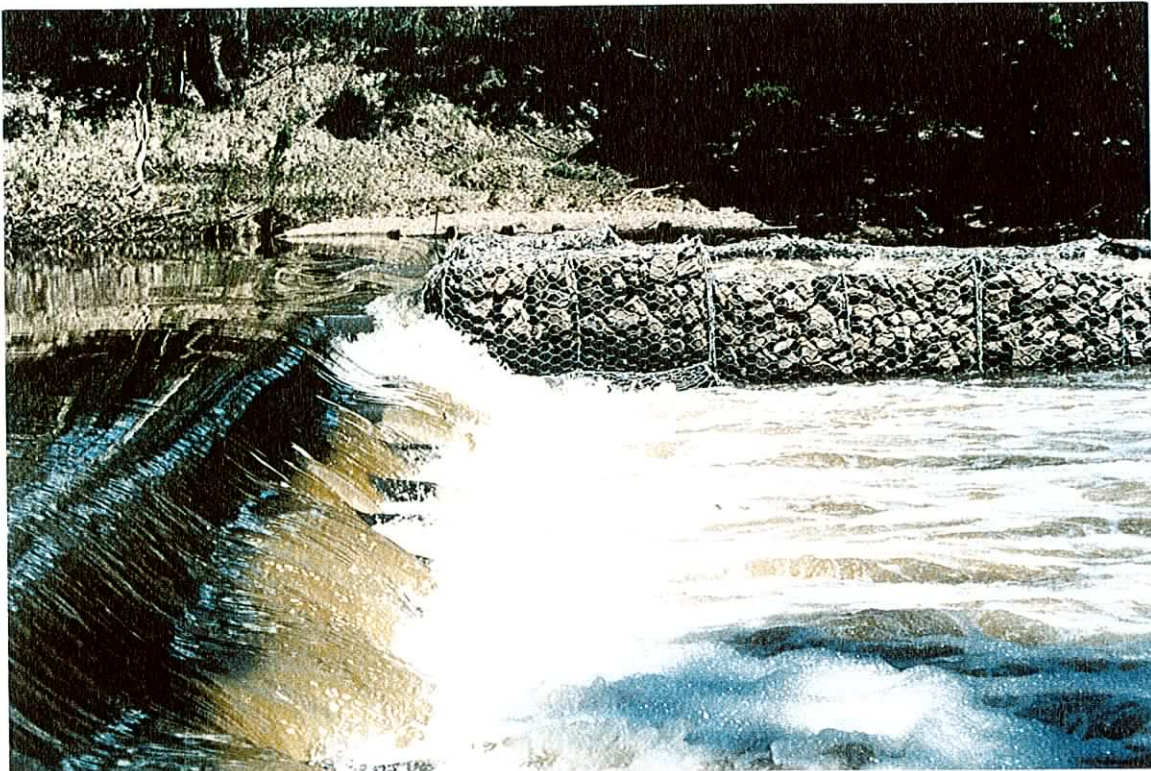
**Photograph 14.** Small spangled perch (*Leiopotherapon unicolor*) can be discerned in several places leaping at the side crest at Goondiwindi weir during 900 ML/day flow down the Macintyre River in March 1996.
